DEPARTMENT OF TRANSPORTATION

Contract #: 04-0120F4Cty: SF/ALA Rte: 80 PM: 13.2/13.9File #: 69.28**WELDING INSPECTION REPORT****Resident Engineer:** Pursell, Gary**Address:** 333 Burma Road**City:** Oakland, CA 94607**Report No:** WIR-001305**Date Inspected:** 26-Dec-2007**Project Name:** SAS Superstructure**OSM Arrival Time:** 700**Prime Contractor:** American Bridge/Fluor Enterprises, a JV**OSM Departure Time:** 1530**Contractor:** Zhenhua Port Machinery Company, Ltd (ZPMC), Changxing Island **Location:** Shanghai, China

WELDING INSPECTION REPORT

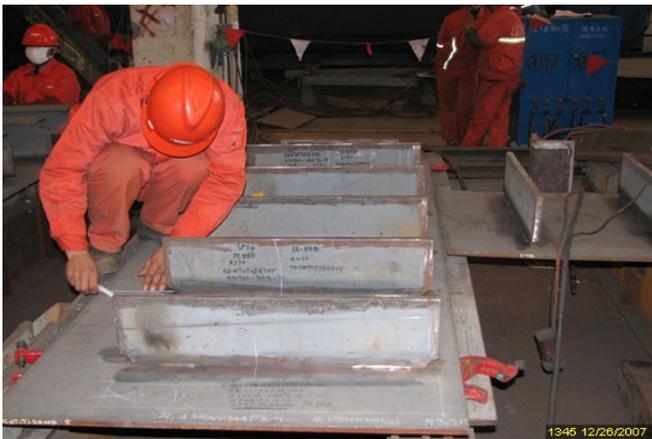
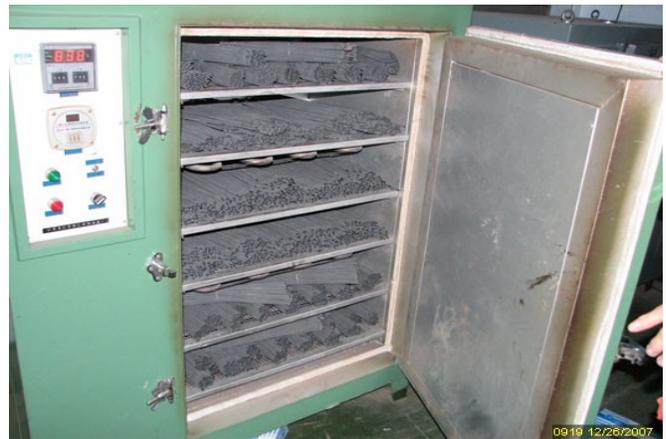
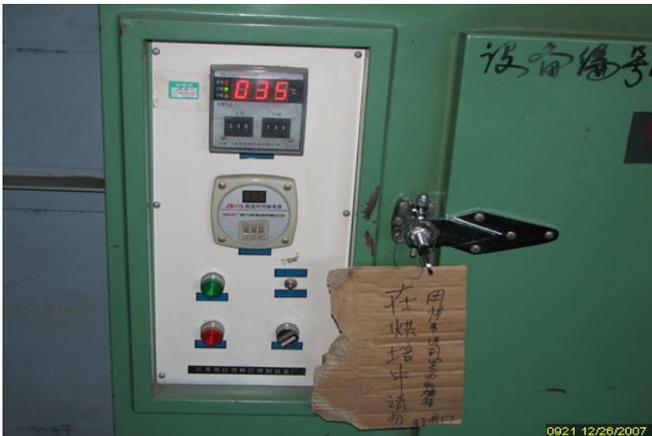
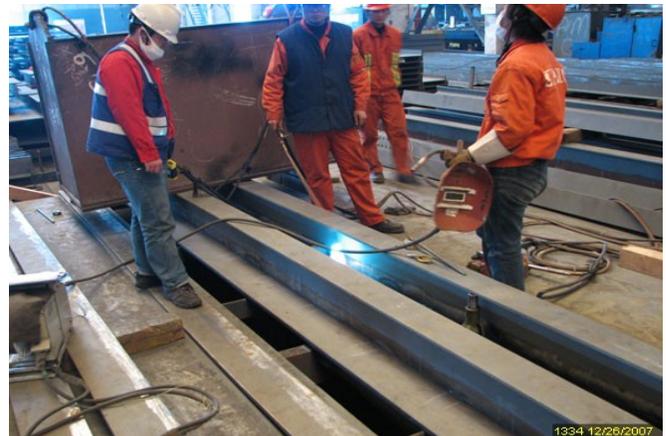
Bay 3- QA Inspector randomly observed ZPMC qualified welder Wei Dashuai, Identification (ID) #051246 performing tack welding on Side Plate SP29 weld joints SP029-01-028 and SP029-01-029 to PL83A and PL83B plates, section #3A-C5. QA Inspector observed that preheating and welding current was monitored by QC Inspector Wu Ming Kai. Flux Core Arc Welding (FCAW) process is being used per the Welding Procedure Specification (WPS) WPS-B-T-2132-2. QA Inspector observed welding parameters of 270 amps and 29.2 volts were used by welder Wei Dashuai #051246. Welding and welding parameters observed by QA Inspector appear to be in general compliance with the approved WPS.

Bay 3- QA Inspector randomly observed ZPMC qualified welder He Yumei, ID# 048625, utilizing the FCAW process using the approved WPS-B-T-2132-2 while performing tack welding on Side Plate SP13 weld joints SP013-01-30/31 and SP013-01-32/33 to PL73A and PL73B plates. QA Inspector observed ZPMC Certified Weld Inspector (CWI) Wu Ming Kai monitoring welding and preheating parameters. The QA Inspector also randomly monitored weld parameters and recorded them as follows: welding amperage 280 amps, welding voltage 28.2 volts. The weld parameters appeared to comply with contract requirements.

Bay 3 - QA Inspector observed weld joints SP034-01-11 thru 20 have been previously tack welded on Side Plate SP34 to plate PL86E. QA Inspector observed the welds during the preparation and cleaning process with electric wire wheel prior to performing preheat and final welding. No discrepancies are noted.

QA Inspector observed ZPMC employee Ly Yangqi transfer all TL-508 welding electrodes from oven #2 and placed them in oven #1. Ly Yangqi then refilled oven #2 with 240 kilograms (kg) of TL-508 welding electrodes. Ly Yangqi then he set the oven temperature to 350 Degrees Celsius for 130 minutes. QA inspector observed that Ly Yangqi recorded this information in a log book and then placed a sign on the oven door that restriction the door to be opened.
