Contract #: 04-0120F4Cty: SF/ALA Rte: 80 PM: 13.2/13.9File #: 69.28**WELDING INSPECTION REPORT****Resident Engineer:** Pursell, Gary**Address:** 333 Burma Road**City:** Oakland, CA 94607**Report No:** WIR-001372**Date Inspected:** 31-Jan-2008**Project Name:** SAS Superstructure**OSM Arrival Time:** 1830**Prime Contractor:** American Bridge/Fluor Enterprises, a JV**OSM Departure Time:** 630**Contractor:** Zhenhua Port Machinery Company, Ltd (ZPMC), Changxing Island **Location:** Shanghai, China

Caltrans Quality Assurance (QA) Inspector, Mike Hasler was present to observe the fitup, welding and related activities associated with the fabricating of Caltrans Mock-up, 77M, 89M, 114M and U-Rib Trial Assembly, for the San Francisco Oakland Bay Self Anchored Suspension Bridge, at Zhenhua Port Machinery Company (ZPMC) facility on Changxing Island.

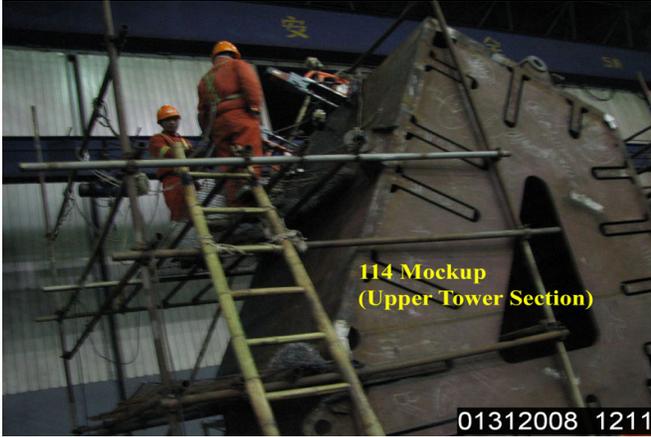
114M (upper tower shaft) Mock-up: Caltrans QA Inspector observed ZPMC shop workers drilling splice connection holes at Skin Plate A. ZPMC performed the match drilling of Skin Plate A using a magnetic drill with an annular drill bit. The drilling of Skin Plate A appeared to be in general conformance with the Tower Splice Mock-up Fabrication Procedure. Following digital picture illustrates the drilling in progress at the work station.
