DEPARTMENT OF TRANSPORTATION

Quality Assurance and Source Inspection

Contract #: 04-0120F4Cty: SF/ALA Rte: 80 PM: 13.2/13.9File #: 69.28**WELDING INSPECTION REPORT****Resident Engineer:** Pursell, Gary**Address:** 333 Burma Road**City:** Oakland, CA 94607**Report No:** WIR-001437**Date Inspected:** 03-Jan-2008**Project Name:** SAS Superstructure**OSM Arrival Time:** 700**Prime Contractor:** American Bridge/Fluor Enterprises, a JV**OSM Departure Time:** 1500**Contractor:** Zhenhua Port Machinery Company, Ltd (ZPMC), Changxing Island **Location:** Shanghai, China**CWI Name:** Huong Wei**CWI Present:** Yes No**Inspected CWI report:** Yes No N/A**Rod Oven in Use:** Yes No N/A**Electrode to specification:** Yes No N/A**Weld Procedures Followed:** Yes No N/A**Qualified Welders:** Yes No N/A**Verified Joint Fit-up:** Yes No N/A**Approved Drawings:** Yes No N/A**Approved WPS:** Yes No N/A**Delayed / Cancelled:** Yes No N/A**Bridge No:** 34-0006**Component:** Check Test Samples & PQR #HP2007531**Summary of Items Observed:**

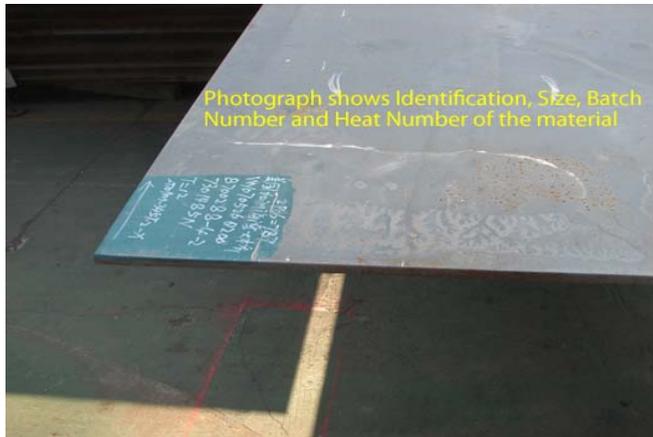
batch numbers, grade, thickness and identification number for batch number eight (8), thirteen (13) and nineteen (19) matched the list of material for the Caltrans Check Test Samples provided. QA Inspector observed that all samples are properly marked for removal with the long dimension transverse to the direction of rolling and 355mm wide by 460mm long. QA Inspector identified each plate and with an arrow indicating the direction of roll and assigned a Caltrans Lot Number for each plate marked for sampling. The following list shows the Caltrans Lot Numbers assigned, heat numbers thickness and grades of the materials sampled. See the photographs on the following page which shows an example of the material identification and marking applied by the QA Inspector.

Photograph shows Identification, Size, Batch Number and Heat Number of the material

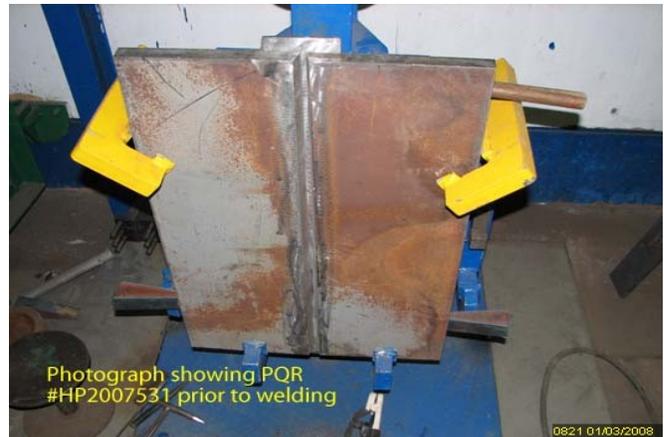
PQR ID #HP2007531 QA Inspector observed ZPMC welder Zhu Haiping ID #066424 perform welding for Procedure Qualification Record Test (PQR) #HP2007531. Base material specification is ASTM Grade 345, Heat #7300320N and is 26mm thick. Welder is observed welding in the 3G position utilizing the SMAW process. Electrodes used for the PQR is described as the following: diameter 3.2mm and 4.0mm diameter, Classification E7018, Brand TL-508, Specification AWS A5.1. QA Inspector observed ZPMC QC Inspector Huong Wei monitor welding parameters per the preliminary WPS. QA Inspector observed interpass cleaning methods by using manual steel wire brush and manual hammer with a chisel. QA Inspector performed random verifications of the welding and parameters for a total of 6 passes. QA Inspector observed that the welding parameters taken by QC Inspector appear to be accurate and in accordance with the contract documents and AWS D1.5 (2002), Qualification Section 5.13. Craig Knops of ABF is present to observe the PQR. QA Inspector did not observe the final weld layers of the PQR and no Lot Number was assigned by the QA Inspector. See the summary of conversations below for more information.

Photograph showing PQR #HP2007531 prior to welding

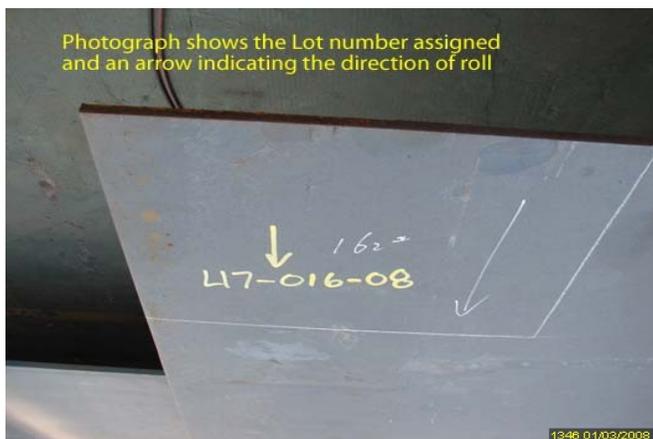
Photograph shows the Lot number assigned and an arrow indicating the direction of roll

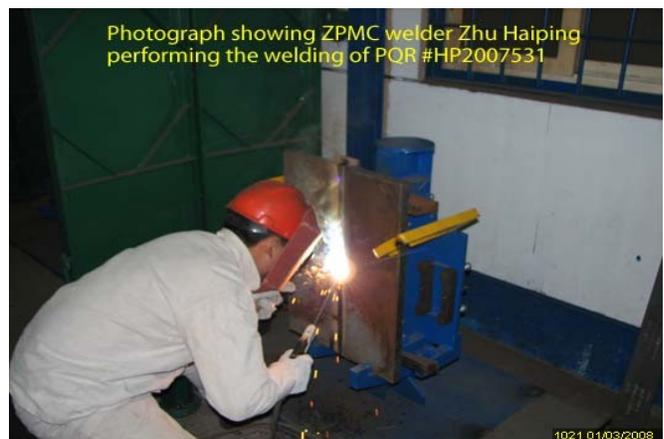
Photograph showing ZPMC welder Zhu Haiping performing the welding of PQR #HP2007531
