DEPARTMENT OF TRANSPORTATION

Contract #: 04-0120F4Cty: SF/ALA Rte: 80 PM: 13.2/13.9File #: 69.28**WELDING INSPECTION REPORT****Resident Engineer:** Pursell, Gary**Address:** 333 Burma Road**City:** Oakland, CA 94607**Report No:** WIR-001455**Date Inspected:** 28-Jan-2008**Project Name:** SAS Superstructure**OSM Arrival Time:** 800**Prime Contractor:** American Bridge/Fluor Enterprises, a JV**OSM Departure Time:** 1400**Contractor:** Zhenhua Port Machinery Company, Ltd (ZPMC), Changxing Island **Location:** Shanghai, China

WELDING INSPECTION REPORT

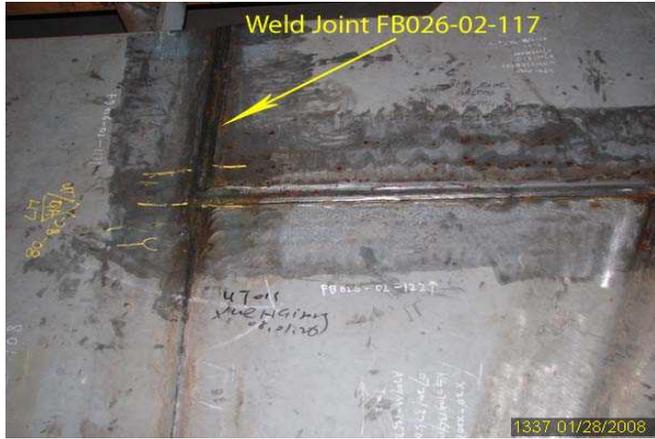
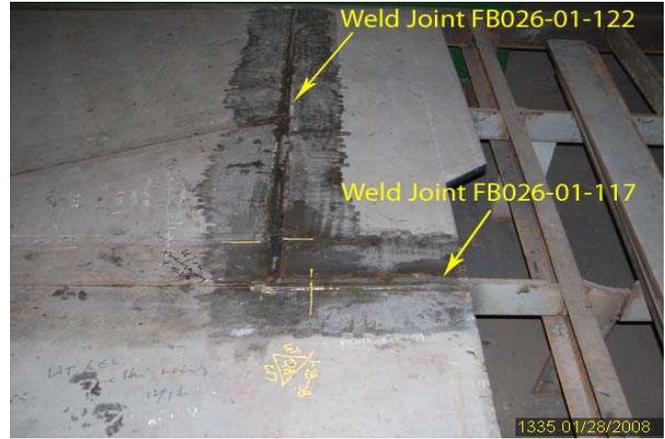
Bay 7- QA Inspector performed ultrasonic verification testing of Floor Beam Sub Assembly Complete Joint Penetration (CJP) welds on Floor Beams FB26-001 and FB27-002 at welds FB026-001-117, FB026-001-122, FB026-002-117 and FB026-002-122. The Ultrasonic Testing (UT) was performed to verify that 10% of the welds meet the requirements of the contract documents and AWS D1.5-2002. The weld and base metal were scanned utilizing a Krautkramer Branson USN 60. QA Inspector performed a base metal lamination check using a 25mm diameter 2.25 MHz transducer and a shear wave scan was using a 20mm x 15mm 2.25 MHz transducer on a 70 degree angle wedge from face A. QA Inspector utilized Scanning patterns A, B, C, and E. For details please see the ultrasonic testing report TL-6027 dated January 28, 2008. QA Inspector found the welds inspected to be in compliance with AWS D1.5- 2002 Table 6.3 and the contract documents.
