Contract #: 04-0120F4Cty: SF/ALA Rte: 80 PM: 13.2/13.9File #: 69.28**WELDING INSPECTION REPORT****Resident Engineer:** Pursell, Gary**Address:** 333 Burma Road**City:** Oakland, CA 94607**Report No:** WIR-001519**Date Inspected:** 16-Feb-2008**Project Name:** SAS Superstructure**OSM Arrival Time:** 700**Prime Contractor:** American Bridge/Fluor Enterprises, a JV**OSM Departure Time:** 1530**Contractor:** Zhenhua Port Machinery Company, Ltd (ZPMC), Changxing Island **Location:** Changxing Island**CWI Name:** Sun Wei**CWI Present:** Yes No**Inspected CWI report:** Yes No N/A**Rod Oven in Use:** Yes No N/A**Electrode to specification:** Yes No N/A**Weld Procedures Followed:** Yes No N/A**Qualified Welders:** Yes No N/A**Verified Joint Fit-up:** Yes No N/A**Approved Drawings:** Yes No N/A**Approved WPS:** Yes No N/A**Delayed / Cancelled:** Yes No N/A**Bridge No:** 34-0006**Component:** OBG DP U-ribs**Summary of Items Observed:**

Caltrans Quality Assurance (QA) Inspector, Larry Viars was present to perform observations of the welding of Orthotropic Box Girder (OBG) U ribs Production Monitoring Test (PMT) and Production Panel, for the San Francisco Oakland Bay Self Anchored Suspension B

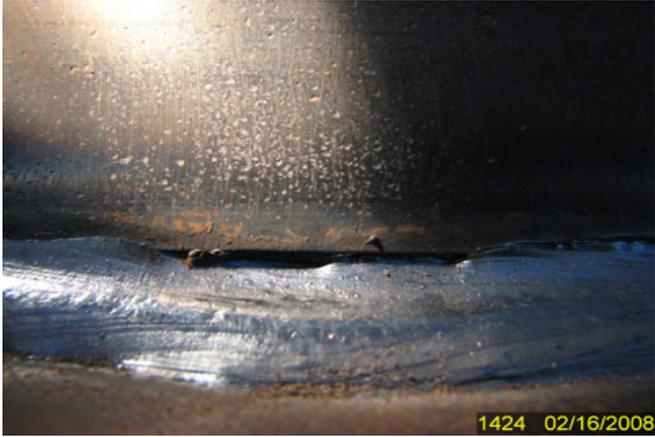
Caltrans QA representative Mr. Greg Bertlesman observed an area of incomplete fusion measuring 270 mm on DP015-001 weld # 3 SAW cover pass prior to ZPMC designating the 500 mm of test area for the PMT.

Caltrans QA observed the following during the welding of the U-ribs for DP058-001. Areas of rust, fins and tears were noted on the weld joint prior to the GMAW root pass. Incomplete fusion was observed on Production panel DP015-001 SAW cover pass. Please see the attached photo of incomplete fusion on weld joint # 1.
