Contract #: 04-0120F4Cty: SF/ALA Rte: 80 PM: 13.2/13.9File #: 69.28**WELDING INSPECTION REPORT****Resident Engineer:** Pursell, Gary**Address:** 333 Burma Road**City:** Oakland, CA 94607**Report No:** WIR-001635**Date Inspected:** 16-Feb-2008**Project Name:** SAS Superstructure**OSM Arrival Time:** 700**Prime Contractor:** American Bridge/Fluor Enterprises, a JV**OSM Departure Time:** 1630**Contractor:** Zhenhua Port Machinery Company, Ltd (ZPMC), Changxing Island **Location:** Shanghai, China**CWI Name:** See Below**CWI Present:** Yes No**Inspected CWI report:** Yes No N/A**Rod Oven in Use:** Yes No N/A**Electrode to specification:** Yes No N/A**Weld Procedures Followed:** Yes No N/A**Qualified Welders:** Yes No N/A**Verified Joint Fit-up:** Yes No N/A**Approved Drawings:** Yes No N/A**Approved WPS:** Yes No N/A**Delayed / Cancelled:** Yes No N/A**Bridge No:** 34-0006**Component:** Tower and OBG Fabrication**Summary of Items Observed:**

Orthotropic Box Girder (OBG) and Tower Mock Up:

WELDING INSPECTION REPORT

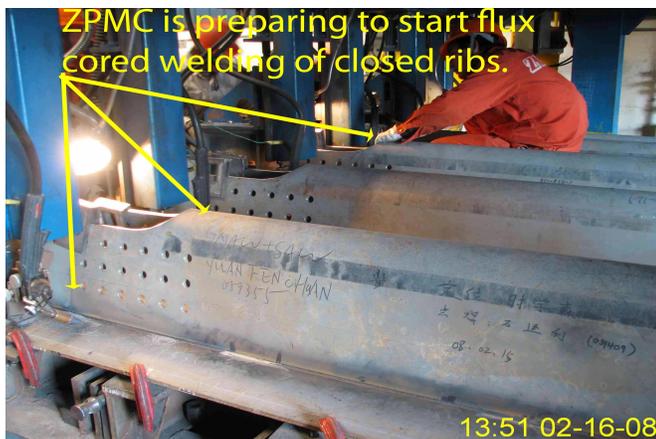
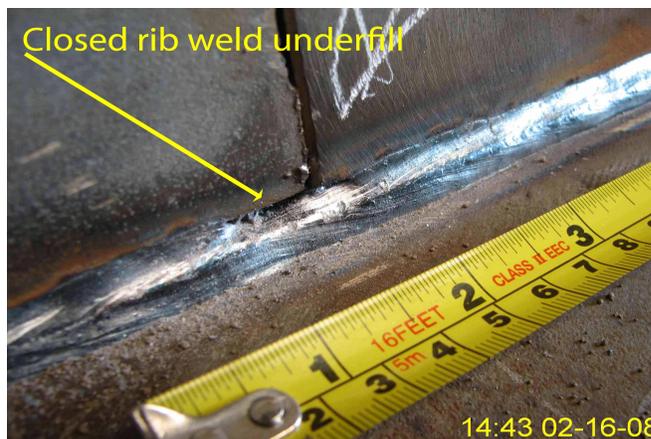
Following completion of the welding of this PMT plate the QA Inspector performed random visual inspection of the six welds and observed several of the welds appear to have weld overlap at the bottom toes of the welds. See

the photographs below for additional information. The QA Inspector observed ZPMC QC Ultrasonic Inspector Mr. LiLi Ming performing ultrasonic (UT) inspection of these six PMT welds to determine the amount of weld penetration. Mr. Ming marked all of the welds as being UT acceptable.
