Contract #: 04-0120F4Cty: SF/ALA Rte: 80 PM: 13.2/13.9File #: 69.28**WELDING INSPECTION REPORT****Resident Engineer:** Pursell, Gary**Address:** 333 Burma Road**City:** Oakland, CA 94607**Report No:** WIR-001643**Date Inspected:** 14-Feb-2008**Project Name:** SAS Superstructure**OSM Arrival Time:** 800**Prime Contractor:** American Bridge/Fluor Enterprises, a JV**OSM Departure Time:** 1530**Contractor:** Zhenhua Port Machinery Company, Ltd (ZPMC), Changxing Island **Location:** Shanghai, China**CWI Name:** See Below**CWI Present:** Yes No**Inspected CWI report:** Yes No N/A**Rod Oven in Use:** Yes No N/A**Electrode to specification:** Yes No N/A**Weld Procedures Followed:** Yes No N/A**Qualified Welders:** Yes No N/A**Verified Joint Fit-up:** Yes No N/A**Approved Drawings:** Yes No N/A**Approved WPS:** Yes No N/A**Delayed / Cancelled:** Yes No N/A**Bridge No:** 34-0006**Component:** Tower and OBG Fabrication**Summary of Items Observed:**

Orthotropic Box Girder (OBG) and Tower Mock Up:

WELDING INSPECTION REPORT

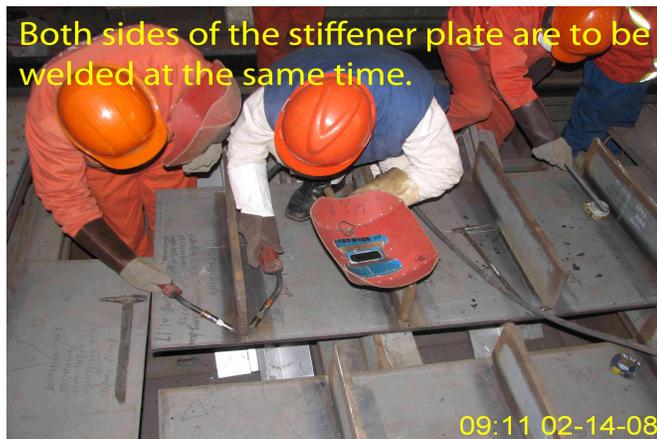
QA Inspector observed ZPMC welder Mr. Li Xhanqian stencil 48810 is using welding procedure specification WPS-B-T-2132-3 using the flux cored welding process for welds on OBG stiffener plate fillet weld SP043-01-006.

The QA Inspector observed a welding current of approximately 280 amps, 28.0 volts, the base material has a minimum preheat temperature of 60° C and the shielding gas flow is approximately 16 cubic liters per hour. The WPS requires a minimum shielding gas flow of 18 cubic liters per hour and the shielding gas flow is below this minimum limit. The QA Inspector informed ZPMC QC CWI Inspector Mr. Wu Ming Kai that the shielding gas flow is below the minimum limit and Mr. Kai had the gas flow adjusted to an acceptable limit. The QA Inspector observed Mr. Xhanqian has a welding travel speed of approximately 290 mm per minute. The WPS requires a minimum travel speed of 392 mm per minute and the welding travel speed is below his minimum limit. The QA Inspector informed ZPMC QC CWI Inspector Mr. Wu Ming Kai that the welding travel speed is too slow. Mr. Kai informed the QA Inspector he will have QC Inspector Mr. Guo Yang Wei inform Mr. Xhanqian to increase his welding travel speed. Later in the shift, the QA Inspector observed Mr. Xhanqian has a welding travel speed of approximately 430 mm per minute, which is in compliance with the WPS acceptable limits. Items observed by the QA Inspector do not appear to fully comply with project specifications.

Note: ZPMC welders Mr. Li Shuliang and Mr. Li Xhanqian are simultaneously welding on the opposite sides of the same stiffener plates. See the photograph below showing both of these welders preparing to weld on the opposite side of a stiffener plate.
