Contract #: 04-0120F4Cty: SF/ALA Rte: 80 PM: 13.2/13.9File #: 69.28**WELDING INSPECTION REPORT****Resident Engineer:** Pursell, Gary**Address:** 333 Burma Road**City:** Oakland, CA 94607**Report No:** WIR-001739**Date Inspected:** 14-Mar-2008**Project Name:** SAS Superstructure**OSM Arrival Time:** 1800**Prime Contractor:** American Bridge/Fluor Enterprises, a JV**OSM Departure Time:** 730**Contractor:** Zhenhua Port Machinery Company, Ltd (ZPMC), Changxing Island **Location:** Shanghai, China**CWI Name:** Li Zhi Jiang**CWI Present:** Yes No**Inspected CWI report:** Yes No N/A**Rod Oven in Use:** Yes No N/A**Electrode to specification:** Yes No N/A**Weld Procedures Followed:** Yes No N/A**Qualified Welders:** Yes No N/A**Verified Joint Fit-up:** Yes No N/A**Approved Drawings:** Yes No N/A**Approved WPS:** Yes No N/A**Delayed / Cancelled:** Yes No N/A**Bridge No:** 34-0006**Component:** Side Plate**Summary of Items Observed:**

Caltrans Quality Assurance (QA) Inspector, Mike Hasler was present to observe the fitup, welding and related activities associated with the fabricating of Caltrans Mock-up, 77M, 89M, 114M and orthotropic box girders (OBG), for the San Francisco Oakland Bay Se

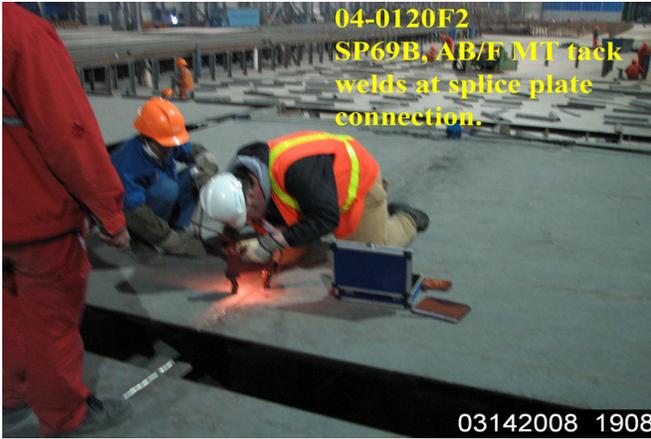
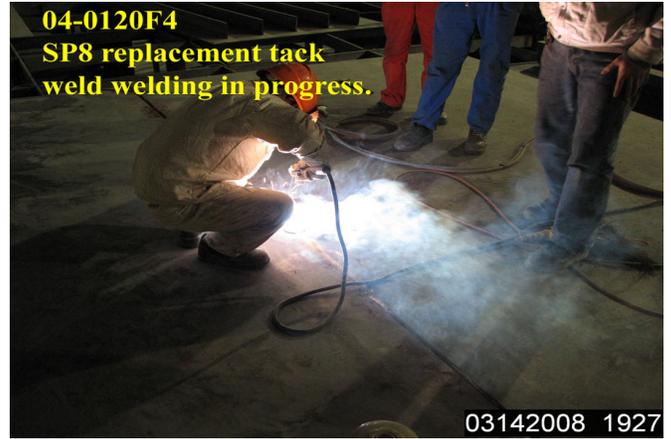
New OBG Building: Caltrans QA Inspector witnessed AB/F inspector, Mr. David La Rue magnetic particle (MT), side plate SP69B, tack welds joining plate splice P104C.(SPCM). The AB/F inspector also MT replacement tack weld at SP8, joining plate splice P69A (SPCM). The welding of the replacement tack weld was performed by welder, identified as Mr. Gu Xueming, welder number 045218. Caltrans QA observed ZPMC QC/CWI, Mr. Li Zhi Jiang monitoring the welding activities. The weld welding procedure specification was identified as WPS-B-P-2211-B-U2, Revision 1. Mr. David LaRue stated that the welding of the plate splice welds was stopped, during the AM shift by AB/F, Mr. Peter Ferguson, until further notice. However, Mr. Ferguson allowed ZPMC to perform fitup and tack welding only. The following digital picture illustrates AB/F MT examination of SP69B tack welds and ZPMC welding the replacement tack weld.
