Contract #: 04-0120F4Cty: SF/ALA Rte: 80 PM: 13.2/13.9File #: 99.28**WELDING INSPECTION REPORT****Resident Engineer:** Pursell, Gary**Address:** 333 Burma Road**City:** Oakland, CA 94607**Report No:** WIR-001793**Date Inspected:** 19-Mar-2008**Project Name:** SAS Superstructure**OSM Arrival Time:** 830**Prime Contractor:** American Bridge/Fluor Enterprises, a JV**OSM Departure Time:** 1830**Contractor:** Japan Steel Works, Ltd.**Location:** Muroran, Japan

CWI Name:	N/A	CWI Present:	Yes	No
Inspected CWI report:	Yes No N/A	Rod Oven in Use:	Yes No N/A	
Electrode to specification:	Yes No N/A	Weld Procedures Followed:	Yes No N/A	
Qualified Welders:	Yes No N/A	Verified Joint Fit-up:	Yes No N/A	
Approved Drawings:	Yes No N/A	Approved WPS:	Yes No N/A	
		Delayed / Cancelled:	Yes No N/A	
Bridge No:	34-0006	Component:	PQR Test Plate, CW-4-1

WELDING INSPECTION REPORT

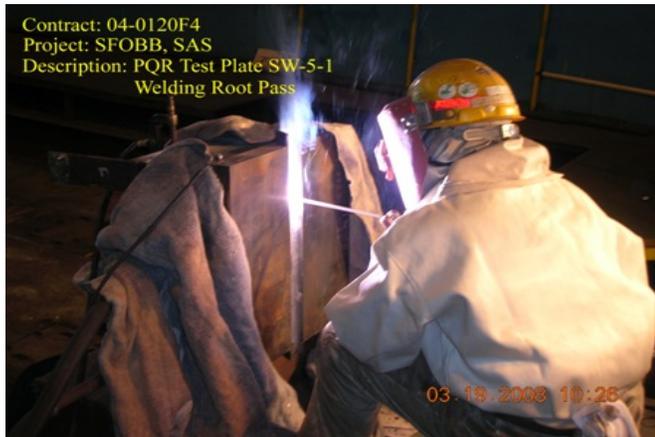
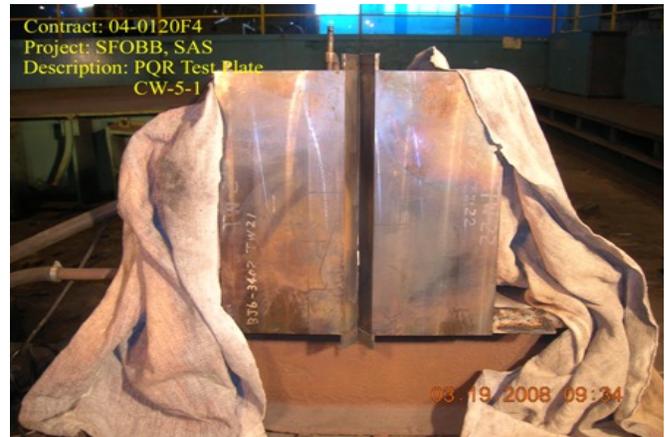
Later in the shift this QA inspector observed Mr. Imai perform the in process weld inspection of the subsequent weld layers and verify the following; the minimum preheat temperature, maximum interpass temperature and the DCEP welding parameters. At the conclusion of the Fifth (5) weld layer (seven individual weld passes) the welder Mr. Sato commence utilizing the 5.0 millimeter electrode. At this time the QA inspector observed Mr. Imai verify the welding parameters which appeared as follows; 172 AC amps, 24.5 AC volts with a travel speed measured at 6 cm/m. The welding of the Test Plate identified as SW-5-1 was not completed during this shift on this date and

appeared to comply with ASME IX and the WPS. (See Digital Photographs)
