**DEPARTMENT OF TRANSPORTATION**

# WELDING INSPECTION REPORT

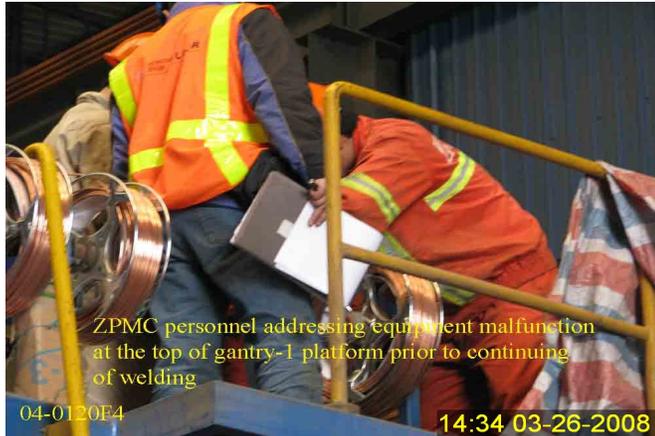
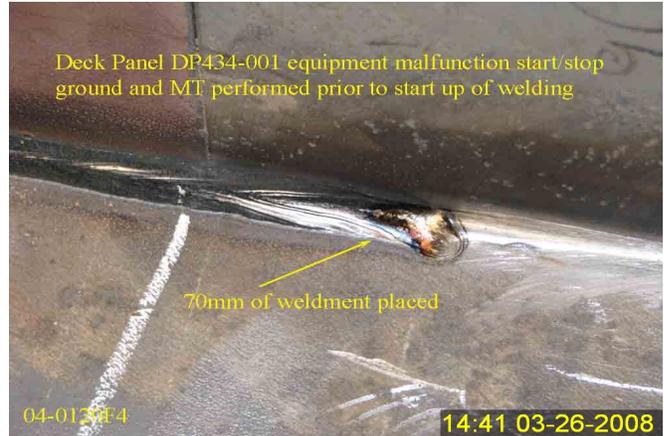
This Quality Assurance (QA) inspector arrived at ZPMC for observation of the SAS super structure fabrication. This QA inspector observed ZPMC weld a Production Monitoring Test (PMT) for deck plate DP191-001 and DP434-001 at gantry-1. Upon completion of the Submerged Arc Welding (SAW) process for PMT-1 met the acceptance criteria for visual and ultrasonic testing. The macros were then laid out to be cut by ZPMC for acceptance. ZPMC then proceeded with the welding of production deck panel number DP191-001 and DP434-001 using the Gas Metal Arc Welding (GMAW) process for the root pass. This QA inspector observed ZPMC welding personnel using gantry # 1 for the welding process and observed that the amperages, voltage and travel speed of each of the 6 welding heads used for production and PMT welding were within the requirements of WPS-B-T-2342-U1 (U Rib)-3. The Ambient temperature in the shop was recorded at 15°C with the steel temperature at 14°C also. Deck panel DP191-001 was welded in two groups group A U96 and U110 group B was U103, U97 and U109. Deck panel DP434-001 was also welded in two groups; group A included Rib numbers U119, U112 and U101. Group B was rib numbers U121 and U114. Upon completion of the GMAW welding process ZPMC proceeded with the Submerged Arc Welding (SAW) process and the welding parameters were also verified to be within the above stated WPS. It was noted that ZPMC had 1-CWI and 4- QC inspectors in bay 1 this date and ABF had 5 QC representatives present this day for bay 1. By the end of this QA inspectors shift ZPMC had not completed the SAW welding for DP434-001 welds 3, 4 and 7, 8 due to ZPMC had an equipment malfunction during the start up of these welds and had stop the process. ZPMC then ground the SAW weldments for 70mm (see digital photos below) and perform MT verification at these locations to ensure weld soundness the welding would continue into the next shift for completion.
