**DEPARTMENT OF TRANSPORTATION**

Contract #: 04-0120F4Cty: SF/ALA Rte: 80 PM: 13.2/13.9File #: 69.28**WELDING INSPECTION REPORT****Resident Engineer:** Pursell, Gary**Address:** 333 Burma Road**City:** Oakland, CA 94607**Report No:** WIR-001970**Date Inspected:** 30-Mar-2008**Project Name:** SAS Superstructure**OSM Arrival Time:** 1800**Prime Contractor:** American Bridge/Fluor Enterprises, a JV**OSM Departure Time:** 730**Contractor:** Zhenhua Port Machinery Company, Ltd (ZPMC), Changxing Island **Location:** Shanghai, China

# WELDING INSPECTION REPORT

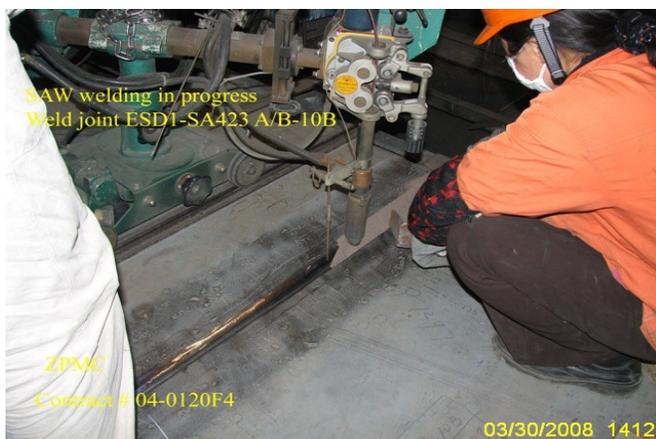
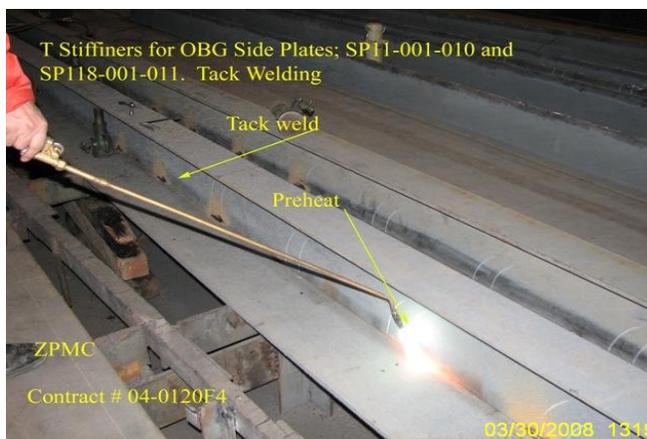
The QA Inspector randomly observed ZPMC Welding Operator Wu Zhi ID 049804, utilizing the Submerged Arc Welding (SAW Process with ZPMC Weld Procedure Specification (WPS) WPS-B-T-3221-U3C-S-1 in the 1F(Flat) position to weld fill passes for weld joint ESD1-SA234A/B-10B.

The QA Inspector visually verified a single electrode was being utilized for the filler passes, the filler metal was LA-85 with a diameter of 4.8 millimeters.

The QA Inspector observed and noted that during the welding operation the ZPMC welding operator would before welding over previous deposited weld pass utilized the proper cleaning method to remove slag prior to resuming the welding operation.

The QA Inspector observed that during the shift ZPMC CWI, Zhao Chen Sun and various ZPMC CAWI Inspectors monitoring the electrical parameters, travel speed and temperatures at several welding stations in Bay #4. The QA Inspector observed that the work performed generally appeared to conform to contract specifications. For more detail see photographs shown below:
