**DEPARTMENT OF TRANSPORTATION**

Contract #: 04-0120F4Cty: SF/ALA Rte: 80 PM: 13.2/13.9File #: 69.28**WELDING INSPECTION REPORT****Resident Engineer:** Pursell, Gary**Address:** 333 Burma Road**City:** Oakland, CA 94607**Report No:** WIR-002003**Date Inspected:** 21-Apr-2008**Project Name:** SAS Superstructure**OSM Arrival Time:** 2300**Prime Contractor:** American Bridge/Fluor Enterprises, a JV**OSM Departure Time:** 730**Contractor:** Zhenhua Port Machinery Company, Ltd (ZPMC), Changxing Island **Location:** Shanghai, China

# WELDING INSPECTION REPORT

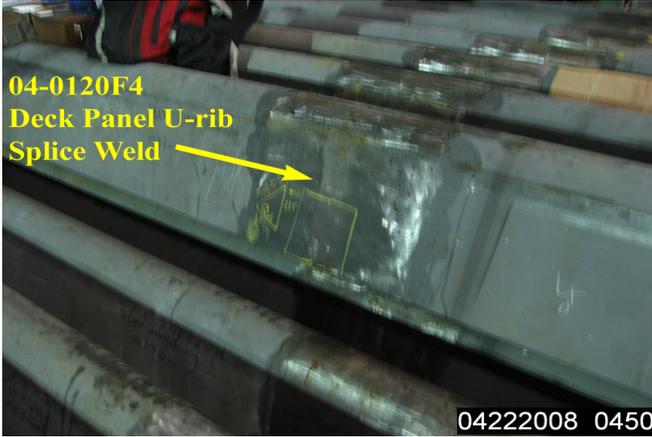
OBG Bay 1: Caltrans QA Inspector performed ultrasonic verification testing of u-rib complete joint penetration butt joint splice weld, identified as DP354-001-190 (U277), DP354-001-191 (U276), DP354-001-192 (U296), DP354-001-193 (U271) and DP354-001-194 (301). The Ultrasonic Testing (UT) was performed to verify that 10% of the weld meets the requirements of the contract documents and AWS D1.5-2002. The weld and base metal were scanned utilizing a Krautkramer Branson USN 60. Caltrans QA Inspector performed a base metal lamination check using a 25mm diameter 2.25 MHz transducer and a shear wave scan was using a 19mm x 16mm 2.25 MHz transducer on a 70 degree angle wedge from face A. Caltrans QA Inspector utilized Scanning patterns A, B, C, and E. Caltrans QA Inspector found the welds inspected to be in compliance with AWS D1.5- 2002 Table 6.3 and the contract documents. See Caltrans Ultrasonic Testing Report (TL-6027), dated April 21, 2008 for additional information. The following digital picture illustrates deck plate u-rib splice weld.
