Contract #: 04-0120F4Cty: SF/ALA Rte: 80 PM: 13.2/13.9File #: 69.28**WELDING INSPECTION REPORT****Resident Engineer:** Pursell, Gary**Address:** 333 Burma Road**City:** Oakland, CA 94607**Report No:** WIR-002011**Date Inspected:** 18-Apr-2008**Project Name:** SAS Superstructure**OSM Arrival Time:** 2300**Prime Contractor:** American Bridge/Fluor Enterprises, a JV**OSM Departure Time:** 730**Contractor:** Zhenhua Port Machinery Company, Ltd (ZPMC), Changxing Island **Location:** Changxing Island**CWI Name:** Chen Xi**CWI Present:** Yes No**Inspected CWI report:** Yes No N/A**Rod Oven in Use:** Yes No N/A**Electrode to specification:** Yes No N/A**Weld Procedures Followed:** Yes No N/A**Qualified Welders:** Yes No N/A**Verified Joint Fit-up:** Yes No N/A**Approved Drawings:** Yes No N/A**Approved WPS:** Yes No N/A**Delayed / Cancelled:** Yes No N/A**Bridge No:** 34-0006**Component:** OBG and Tower**Summary of Items Observed:**

WELDING INSPECTION REPORT

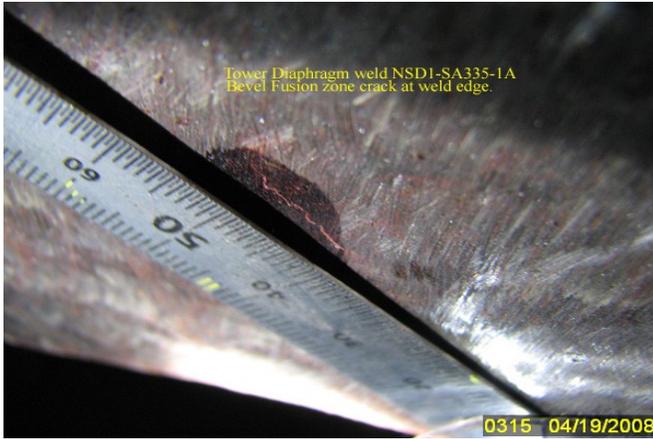
The Caltrans QA Inspector performed Magnetic Particle Testing (MT) the 43 meter North Tower shaft bottom plate weld # NSD1-SA335 1A (SA335 to P459). During testing a 15 mm crack was found in the bevel to weld fusion zone at the weld termination. ZPMC QC Mr. Botin Rui had found the weld to be acceptable on 4-17-08. An incident report was issued for the Quality Control (QC) oversight. Please see MT report TL-6028 generated on this date for further information. The attached photo below shows the above mentioned crack found during MT.
