DEPARTMENT OF TRANSPORTATION

Quality Assurance and Source Inspection

Contract #: 04-0120F4Cty: SF/ALA Rte: 80 PM: 13.2/13.9File #: 69.28**WELDING INSPECTION REPORT****Resident Engineer:** Pursell, Gary**Address:** 333 Burma Road**City:** Oakland, CA 94607**Report No:** WIR-002051**Date Inspected:** 17-Dec-2007**Project Name:** SAS Superstructure**OSM Arrival Time:** 700**Prime Contractor:** American Bridge/Fluor Enterprises, a JV**OSM Departure Time:** 1530**Contractor:** Zhenhua Port Machinery Company, Ltd (ZPMC), Changxing Island **Location:** Shanghai, China**CWI Name:** Wu Zhifeng, Xu Xianping**CWI Present:** Yes No**Inspected CWI report:** Yes No N/A**Rod Oven in Use:** Yes No N/A**Electrode to specification:** Yes No N/A**Weld Procedures Followed:** Yes No N/A**Qualified Welders:** Yes No N/A**Verified Joint Fit-up:** Yes No N/A**Approved Drawings:** Yes No N/A**Approved WPS:** Yes No N/A**Delayed / Cancelled:** Yes No N/A**Bridge No:** 34-0006**Component:** OBG Components**Summary of Items Observed:**

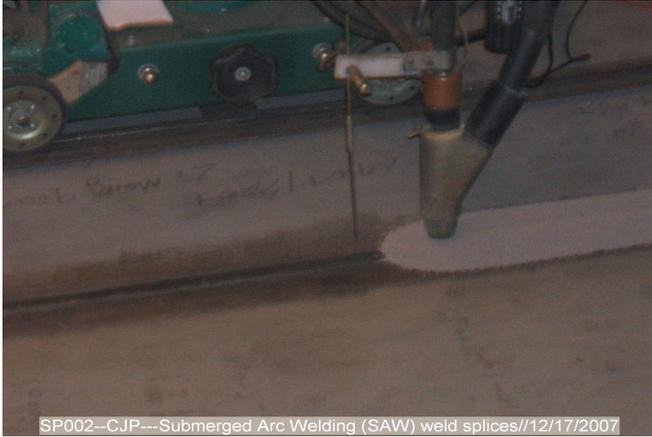
Side Plate (SP)035-01-(001-010), The QA Inspector checked the welding parameters, and measured and recorded--176 amps, 21.8 volts. The QA Inspector asked Z. P. M. C., QC personnel the required WPS, and was initially told WPS-B-T-2132-2-. The QA Inspector was in the process of verifying the information provided, when other QC personnel provided additional WPS information. After determining that the QA Inspector, had initially been given the wrong WPS, the correct one, WPS-B-P-2212-FCAW, was given. During this process, the QA Inspector, asked why the Welder was using electrode--TL-508, when the electrode, specified on the WPS, was THJ-5015-FE-1, Z. P. M. C. personnel, rather quickly realized their mistake / miscommunication. The work had not started at this point, as the Inspector, had been nearby, and saw the Welder approach with his tools. Z. P. M. C., Welder--Wang Jian--067081, began making weld repairs, on the mentioned piece.

Z. P. M. C. personnel are working on SP035-01-(001-010), and Plate 90A, SP041-01-(001-010).
