Contract #: 04-0120F4Cty: SF/ALA Rte: 80 PM: 13.2/13.9File #: 70.28**WELDING INSPECTION REPORT****Resident Engineer:** Pursell, Gary**Address:** 333 Burma Road**City:** Oakland, CA 94607**Report No:** WIR-002056**Date Inspected:** 25-Apr-2008**Project Name:** SAS Superstructure**Prime Contractor:** American Bridge/Fluor Enterprises, a JV**Contractor:** Japan Steel Works**OSM Arrival Time:** 930**OSM Departure Time:** 1630**Location:** Muroran, Japan

WELDING INSPECTION REPORT

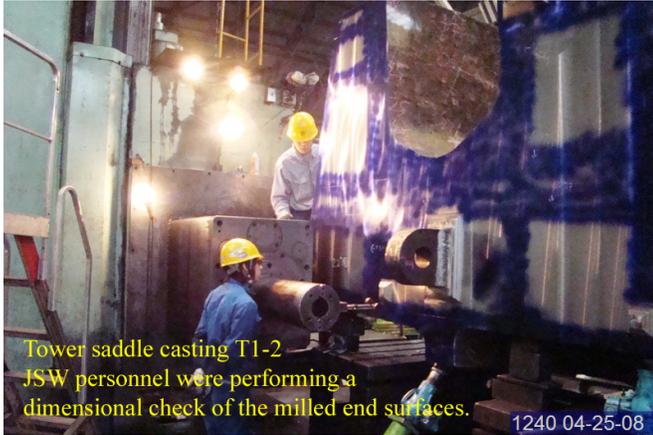
On this date the QA representative Joe Lanz arrived at Japan Steel Works (JSW) of Muroran Japan and traveled to Machine shop number 2 at 1400 hours escorted by JSW representative Mr. Koji Kanazawa. The QA inspector observed the Tower saddle casting designated T1-2 was in process of rough milling end the faces on a horizontal mill. Both end faces had been milled to a rough dimension approximately 10 mm greater than the final dimension. At the time of the QA inspector's observation, two JSW personnel were performing a dimensional check of the milled end surfaces. See the digital images below for further detail. No work was performed at the time of

inspection.
