DEPARTMENT OF TRANSPORTATION

Quality Assurance and Source Inspection

WELDING INSPECTION REPORT

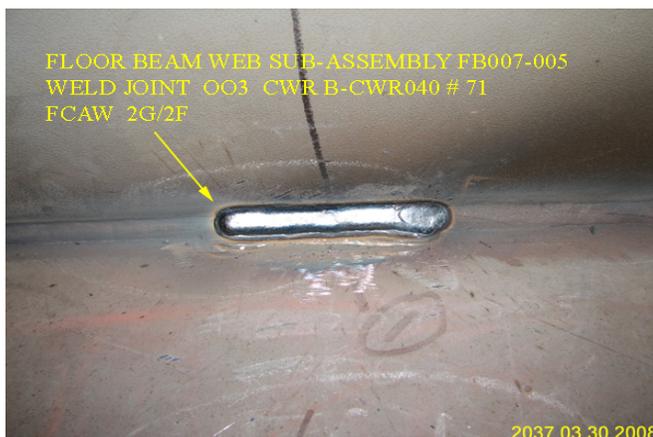
The QA Inspector randomly observed ZPMC welder Zhang Chen Chuanzong ID Number 044824, utilizing the FCAW Process in the 2G/2F (Horizontal Groove/Horizontal Fillet) Positions with ZPMC WPS WPS-345-FCAW-2G(2F)Repair-1, on a repair to WJ 009 on Floor Beam Diaphragm Web Sub-Assembly FB007-01, in accordance with ZPMC Critical Weld Repair (CWR) B-CWR040. The QA Inspector randomly observed ZPMC CWI Hu Wei Qing monitoring weld parameters. The QA Inspector also randomly monitored weld parameters and recorded them as follows: 292 amps, 29.7 volts with a travel speed of 525 mm per minute. The weld parameters appeared to comply with contract requirements. The attached photograph provides additional detail.

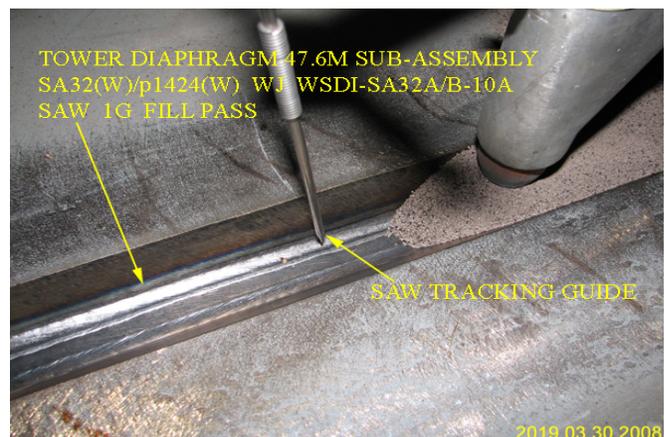
The QA Inspector randomly observed ZPMC welder Ma Ying ID Number 045270, utilizing the SAW Process in the 1G Position (Flat Groove) with ZPMC WPS WPS-B-T-3221-B-U3c-S-1, to weld the fill pass in WJ WSD1-SA32A/B-10A on Tower Diaphragm Sub-Assembly SA32(W) to p1424(W). The QA Inspector randomly observed ZPMC CWI Ye Yongjun monitoring weld parameters. The QA Inspector also randomly monitored weld parameters and recorded them as follows: 615 amps, 30.8 volts with a travel speed of 500 mm per minute. The weld parameters appeared to comply with contract requirements. The attached photograph provides additional detail.
