DEPARTMENT OF TRANSPORTATION

Contract #: 04-0120F4Cty: SF/ALA Rte: 80 PM: 13.2/13.9File #: 69.28**WELDING INSPECTION REPORT****Resident Engineer:** Pursell, Gary**Address:** 333 Burma Road**City:** Oakland, CA 94607**Report No:** WIR-002094**Date Inspected:** 08-Apr-2008**Project Name:** SAS Superstructure**OSM Arrival Time:** 700**Prime Contractor:** American Bridge/Fluor Enterprises, a JV**OSM Departure Time:** 1730**Contractor:** Zhenhua Port Machinery Company, Ltd (ZPMC), Changxing Island **Location:** Shanghai, China**CWI Name:** Huang Wen pang/Shi Zhi**CWI Present:** Yes No**Inspected CWI report:** Yes No N/A**Rod Oven in Use:** Yes No N/A**Electrode to specification:** Yes No N/A**Weld Procedures Followed:** Yes No N/A**Qualified Welders:** Yes No N/A**Verified Joint Fit-up:** Yes No N/A**Approved Drawings:** Yes No N/A**Approved WPS:** Yes No N/A**Delayed / Cancelled:** Yes No N/A**Bridge No:** 34-0006**Component:** OBG/Tower**Summary of Items Observed:**

WELDING INSPECTION REPORT

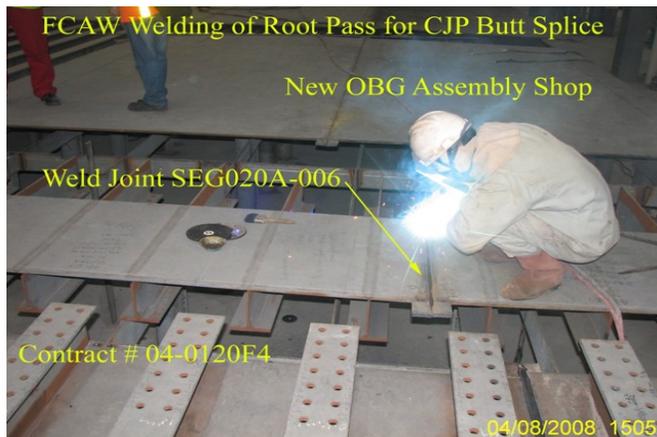
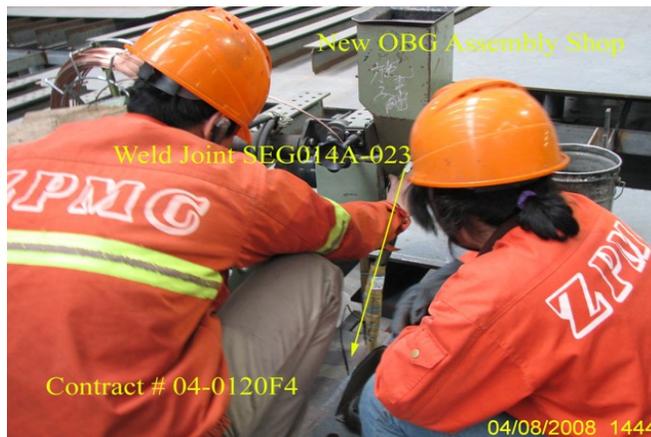
The work being performed was in progress generally appeared to conform to contract specifications. For more detail see Photographs shown below:
