DEPARTMENT OF TRANSPORTATION

Quality Assurance and Source Inspection

Contract #: 04-0120F4Cty: SF/ALA Rte: 80 PM: 13.2/13.9File #: 69.28**WELDING INSPECTION REPORT****Resident Engineer:** Pursell, Gary**Address:** 333 Burma Road**City:** Oakland, CA 94607**Report No:** WIR-002156**Date Inspected:** 21-Apr-2008**Project Name:** SAS Superstructure**OSM Arrival Time:** 1300**Prime Contractor:** American Bridge/Fluor Enterprises, a JV**OSM Departure Time:** 2200**Contractor:** Zhenhua Port Machinery Company, Ltd (ZPMC), Changxing Island **Location:** Shanghai, China**CWI Name:** Sai Fa Wang**CWI Present:** Yes No**Inspected CWI report:** Yes No N/A**Rod Oven in Use:** Yes No N/A**Electrode to specification:** Yes No N/A**Weld Procedures Followed:** Yes No N/A**Qualified Welders:** Yes No N/A**Verified Joint Fit-up:** Yes No N/A**Approved Drawings:** Yes No N/A**Approved WPS:** Yes No N/A**Delayed / Cancelled:** Yes No N/A**Bridge No:** 34-0006**Component:** OBG/Tower**Summary of Items Observed:**

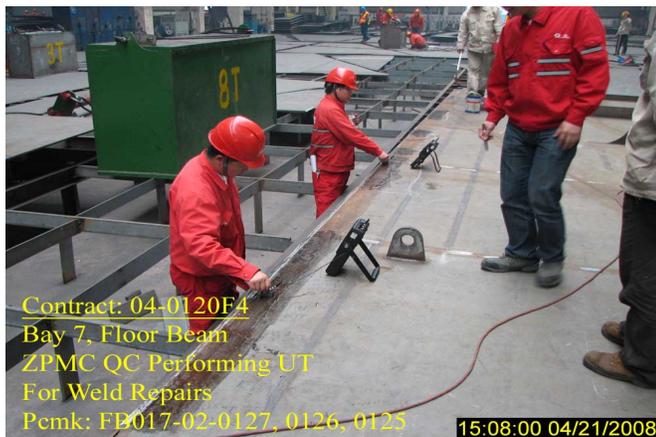
The QA Inspector performed random observations in bay 7 and observed ZPMC QC personnel performing ultrasonic testing (UT) for several areas on the floor beam panels that were previously rejected by UT and repaired (see digital photo below). The UT that was witnessed during this observation was being performed on floor beam designation FB022-01-125, FB022-01-126 and FB022-01-127. The QA Inspector observed ZPMC UT personnel reject several repaired areas on along weld joint 126 and 127. No relevant indications were documented by ZPMC upon completing UT inspection on weld 125. The QA Inspector also noted weld joint 125 as a seismic performance critical member (SPMC). The ZPMC personnel performing UT on this assembly were identified as Li Liming and Ma Jilong. The QA Inspector observed the personnel measure out the Y coordinates for each rejectable indication and write down the information pertaining to each one.
