DEPARTMENT OF TRANSPORTATION

Contract #: 04-0120F4Cty: SF/ALA Rte: 80 PM: 13.2/13.9File #: 69.28**WELDING INSPECTION REPORT****Resident Engineer:** Pursell, Gary**Address:** 333 Burma Road**City:** Oakland, CA 94607**Report No:** WIR-002164**Date Inspected:** 11-Apr-2008**Project Name:** SAS Superstructure**OSM Arrival Time:** 1400**Prime Contractor:** American Bridge/Fluor Enterprises, a JV**OSM Departure Time:** 2300**Contractor:** Zhenhua Port Machinery Company, Ltd (ZPMC), Changxing Island **Location:** Shanghai, China

Summary of Items Observed:

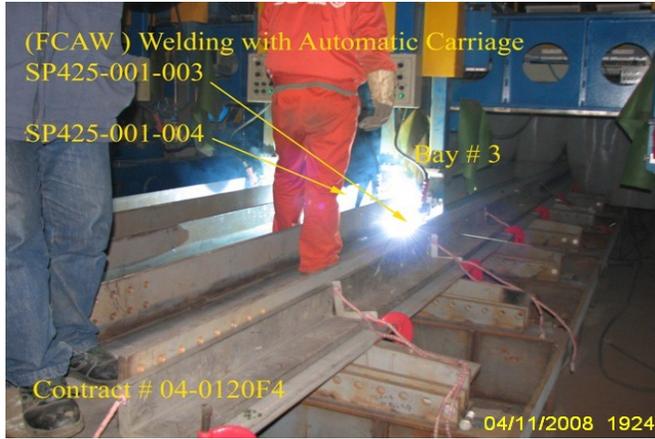
The QA Inspector randomly observed ZPMC Welder Sun Ti Yu ID 054459 utilizing the FCAW Process with ZPMC Weld Procedure Specification (WPS) WPS-B-T-2132-3 in the 2F (Horizontal) position utilizing the Automatic Welding Carriage, to weld various stiffeners to Side Plate Sub-Assembly SP425-001.

The QA Inspector made a random visual verification of the welding in progress on the following weld joints: SP425-001-003 and 004, 004.

For more detail see photograph shown below:
