DEPARTMENT OF TRANSPORTATION

Contract #: 04-0120F4Cty: SF/ALA Rte: 80 PM: 13.2/13.9File #: 99.28**WELDING INSPECTION REPORT****Resident Engineer:** Pursell, Gary**Address:** 333 Burma Road**City:** Oakland, CA 94607**Report No:** WIR-002216**Date Inspected:** 31-Mar-2008**Project Name:** SAS Superstructure**OSM Arrival Time:** 830**Prime Contractor:** American Bridge/Fluor Enterprises, a JV**OSM Departure Time:** 1830**Contractor:** Japan Steel Works, Ltd.**Location:** Muroran, Japan**CWI Name:** Makhmud Ashadi**CWI Present:** Yes No**Inspected CWI report:** Yes No N/A**Rod Oven in Use:** Yes No N/A**Electrode to specification:** Yes No N/A**Weld Procedures Followed:** Yes No N/A**Qualified Welders:** Yes No N/A**Verified Joint Fit-up:** Yes No N/A**Approved Drawings:** Yes No N/A**Approved WPS:** Yes No N/A**Delayed / Cancelled:** Yes No N/A**Bridge No:** 34-0006**Component:** Tower, Jacking and Deviation Saddles**Summary of Items Observed:**

WELDING INSPECTION REPORT

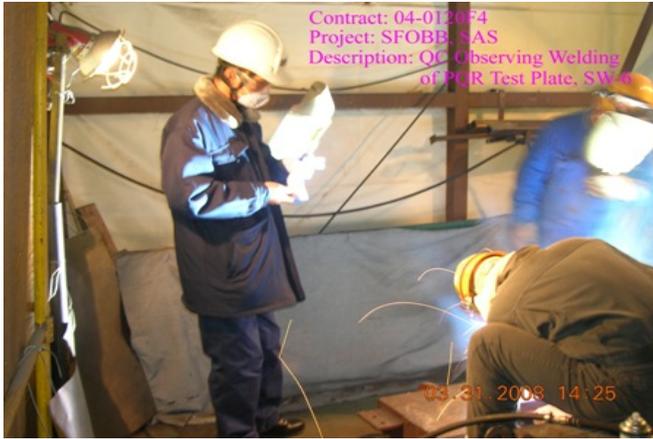
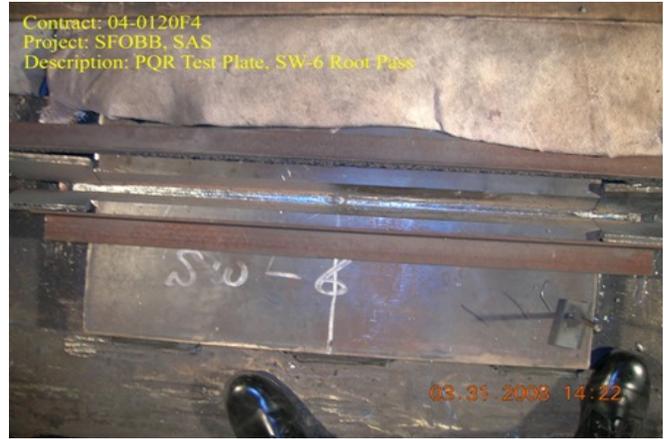
At the start of the shift this QA inspector observed the welding and inspection of the Procedure Qualification Record (PQR) test plate identified as SW-6. The welding was performed by Japan Steel Works, Ltd. welding personnel Naoki Murai ID 97-2118 with the test plate placed to the Flat (1G) position. Mr. Murai utilized the gas shielded Flux Cored Arc Welding (FCAW-G) as per the Welding Procedure Specification (WPS) SJ-2942 WP-9 which was also used by Intertek Testing Services (ITS) Quality Control (QC) Inspector Makhmud Ashadi as a reference. The consumable utilized during the welding of the test plate was identified as a Hobart Brothers Electrode, Tri-Mark TM-55 with a diameter size of 1.6 millimeters. Prior to the welding of the test plate, Mr. Ashadi verified the assembly fit-up of the single-v-groove weld which appeared to comply with the AWS D1.5 -02 Joint Designation identified as B-U2-GF and the minimum preheat temperature of 110 degrees Celsius.

At this time the welder commence the welding of the test plate and this QA inspector observed the QC inspector verifying the amperage, voltage and travel speed. The average welding parameters were observed by this QA inspector were as follows; 335 amps, 36.0 volts with a travel speed measured at 260 mm/m.

Later in the shift this QA inspector observed, at random intervals, the QC inspector Makhmud Ashadi perform the in process weld inspection and verifying the minimum preheat and maximum interpass temperatures. The welding of the Test Plate identified as SW-6 was not completed during this shift on this date and appeared to comply with the WPS. (See Digital Photographs)
