DEPARTMENT OF TRANSPORTATION

Quality Assurance and Source Inspection

Contract #: 04-0120F4Cty: SF/ALA Rte: 80 PM: 13.2/13.9File #: 69.28**WELDING INSPECTION REPORT****Resident Engineer:** Pursell, Gary**Address:** 333 Burma Road**City:** Oakland, CA 94607**Report No:** WIR-002230**Date Inspected:** 20-Apr-2008**Project Name:** SAS Superstructure**OSM Arrival Time:** 630**Prime Contractor:** American Bridge/Fluor Enterprises, a JV**OSM Departure Time:** 1530**Contractor:** Zhenhua Port Machinery Company, Ltd (ZPMC), Changxing Island **Location:** Shanghai, China**CWI Name:** Sun Wei**CWI Present:** Yes No**Inspected CWI report:** Yes No N/A**Rod Oven in Use:** Yes No N/A**Electrode to specification:** Yes No N/A**Weld Procedures Followed:** Yes No N/A**Qualified Welders:** Yes No N/A**Verified Joint Fit-up:** Yes No N/A**Approved Drawings:** Yes No N/A**Approved WPS:** Yes No N/A**Delayed / Cancelled:** Yes No N/A**Bridge No:** 34-0006**Component:** Tower Skin Plates**Summary of Items Observed:**

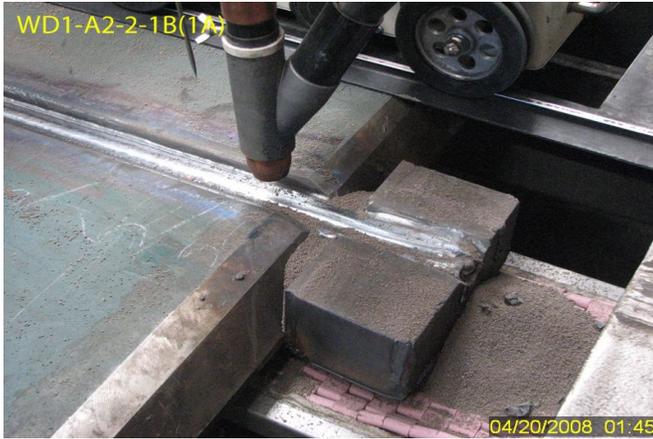
The QA Inspector randomly observed ZPMC qualified welder Ms. Ma Ying, ID #045370, performing groove welding of weld joint WD1-A2-2-1B(1A) filler passes. Ms. Ma was observed welding in the 1G (flat) position utilizing a Submerged Arc Welding (SAW) process with a 4.8mm diameter electrode, filler metal brand LA-85, class MIL800-HPNI, machine.

The QA Inspector randomly observed ZPMC qualified welder Ms. Yuan Tag Chuan, ID #059355, performing groove welding of weld joint WD1-A2-2-1B(1A) filler passes. Ms. Yuan was observed welding in the 1G (flat) position utilizing a Submerged Arc Welding (SAW) process with a 4.8mm diameter electrode, filler metal brand LA-85, class MIL800-HPNI, machine.
