Contract #: 04-0120F4Cty: SF/ALA Rte: 80 PM: 13.2/13.9File #: 69.28**WELDING INSPECTION REPORT****Resident Engineer:** Pursell, Gary**Address:** 333 Burma Road**City:** Oakland, CA 94607**Report No:** WIR-002233**Date Inspected:** 09-May-2008**Project Name:** SAS Superstructure**OSM Arrival Time:** 1400**Prime Contractor:** American Bridge/Fluor Enterprises, a JV**OSM Departure Time:** 300**Contractor:** Zhenhua Port Machinery Company, Ltd (ZPMC), Changxing Island **Location:** Shanghai, China**CWI Name:** Chen Xi**CWI Present:** Yes No**Inspected CWI report:** Yes No N/A**Rod Oven in Use:** Yes No N/A**Electrode to specification:** Yes No N/A**Weld Procedures Followed:** Yes No N/A**Qualified Welders:** Yes No N/A**Verified Joint Fit-up:** Yes No N/A**Approved Drawings:** Yes No N/A**Approved WPS:** Yes No N/A**Delayed / Cancelled:** Yes No N/A**Bridge No:** 34-0006**Component:** OBG side and bottom panels**Summary of Items Observed:**

OBG new assembly bay

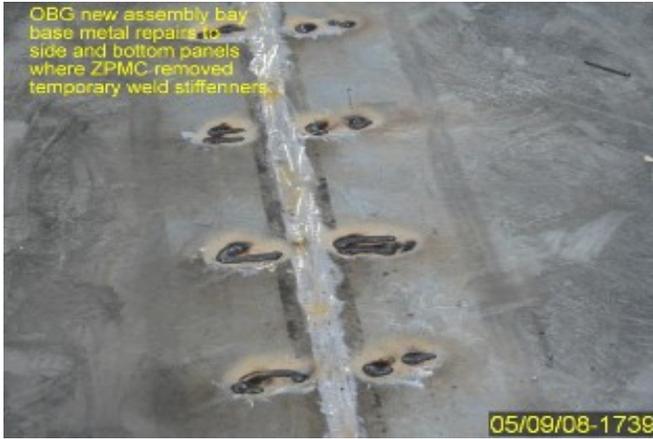
QA observed ZPMC perform base metal repairs in the areas where temporary weld stiffeners were used to minimize weld distortion were removed on the following side and bottom panels: SEG-717A-006, SEG-014A-003, SEG-014A-019, SEG-019A-002 and SEG-017A-002. QA noted that ZPMC did not perform Magnetic particle Testing (MT) of the excavated areas prior to performing the weld repairs as specified in the approved weld repair procedure WPS-345-SMAW-1G (1F)-FCM-Repair. QA notified ZPMC QC CWI identified as Mr. Chen Xi and ABF QC inspector identified as Li Jing Bo of a Caltrans QA incident report concerning this issue.
