Contract #: 04-0120F4Cty: SF/ALA Rte: 80 PM: 13.2/13.9File #: 13.28**WELDING INSPECTION REPORT****Resident Engineer:** Pursell, Gary**Address:** 333 Burma Road**City:** Oakland, CA 94607**Report No:** WIR-002247**Date Inspected:** 07-May-2008**Project Name:** SAS Superstructure**OSM Arrival Time:** 800**Prime Contractor:** American Bridge/Fluor Enterprises, a JV**OSM Departure Time:** 1530**Contractor:** Oregon Iron Works Clackamas, Or.**Location:** Clackamas, OR

Bridge No: 34-0006**Component:** Hinge K fuse overlay mockup**Summary of Items Observed:**

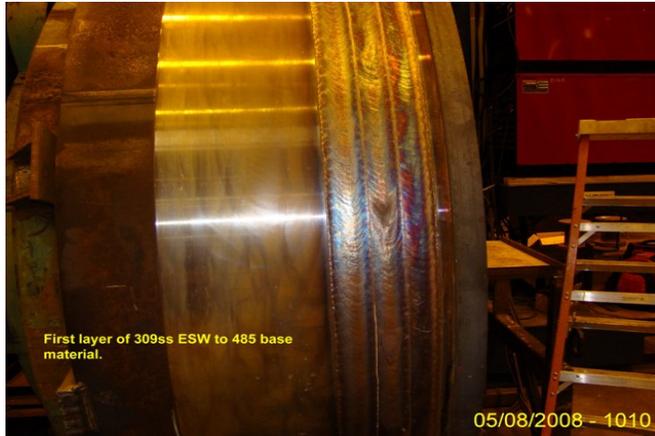
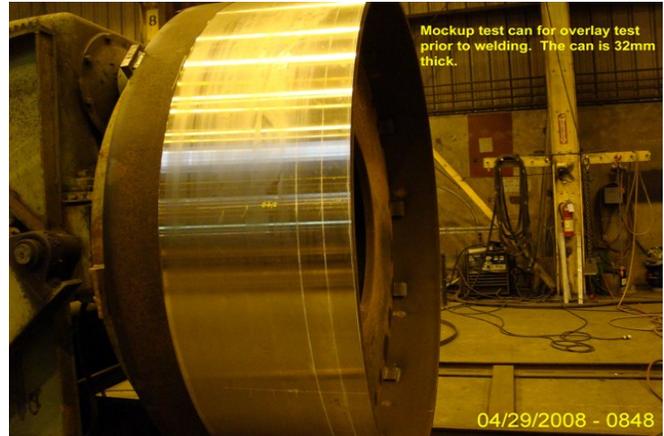
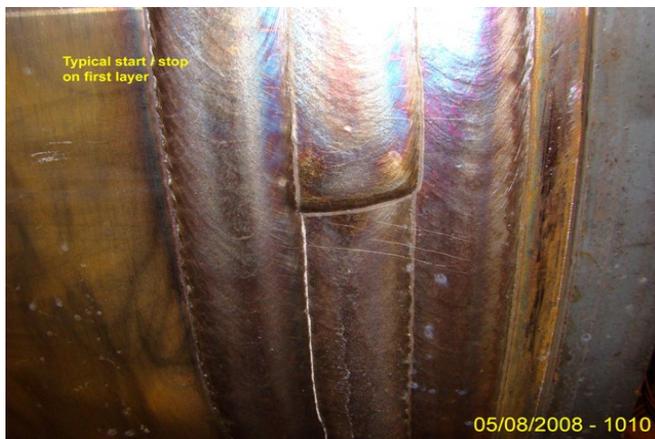
The Base material was said to be ASTM A709 Gr 70W HPS heat number 108571 from Oregon Steel Mills. The Material was measured to be 32mm by the QA. The Electro used on the first layer was observed to be Soudotape 309L strip welding material. The flux used was EN760 (ES) AFB-2

The QA Inspector observed the Amps to be 1250 and the Volts to be 24.3. The travel speed was recorded at 275mm per minute.

The photos below show the process being observed.
