**DEPARTMENT OF TRANSPORTATION**

Contract #: 04-0120F4Cty: SF/ALA Rte: 80 PM: 13.2/13.9File #: 69.28**WELDING INSPECTION REPORT****Resident Engineer:** Pursell, Gary**Address:** 333 Burma Road**City:** Oakland, CA 94607**Report No:** WIR-002314**Date Inspected:** 12-May-2008**Project Name:** SAS Superstructure**OSM Arrival Time:** 1400**Prime Contractor:** American Bridge/Fluor Enterprises, a JV**OSM Departure Time:** 2300**Contractor:** Zhenhua Port Machinery Company, Ltd (ZPMC), Changxing Island **Location:** Shanghai, China

**Production Monitoring Tests – Macro-Etches**

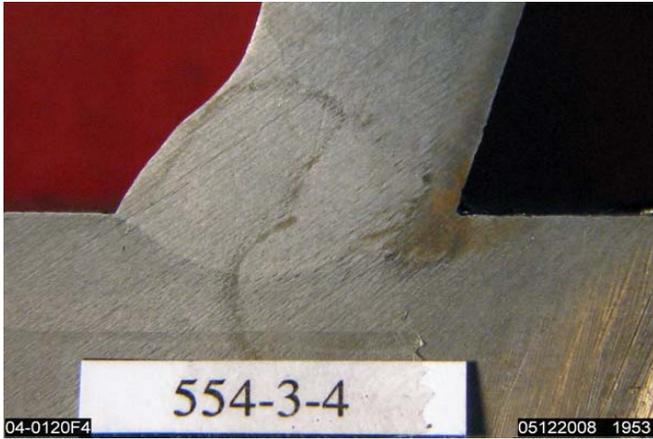
One set (15) of Production Monitoring Tests (PMT's) was examined. The Macro-Etch samples for U ribs to deck panels were identified as DP-554-001 and DP-549-002. The PMT's were welded on 05-12-08. Both ZPMC QC and ABF QA had accepted the samples prior to Caltrans Inspectors' visual examination. All samples except 554-5-4 appeared to contain penetration greater than 80 percent. Sample 554-5-4 appeared to have less than 80 percent penetration, but more than 70 percent. According to the criteria, this is acceptable but recordable and was logged as such. The QA Inspector observed that sample 554-3-4 appeared to have an acceptable inclusion. All the data from the review was recorded in a tracking log and forwarded to Quality Assurance Task leaders and Structural Materials representatives. The samples were digitally photographed and placed on the internal server for future reference. Below is a photograph of sample 554-3-4.
