DEPARTMENT OF TRANSPORTATION

Quality Assurance and Source Inspection

Contract #: 04-0120F4Cty: SF/ALA Rte: 80 PM: 13.2/13.9File #: 69.28**WELDING INSPECTION REPORT****Resident Engineer:** Pursell, Gary**Address:** 333 Burma Road**City:** Oakland, CA 94607**Report No:** WIR-002634**Date Inspected:** 02-May-2008**Project Name:** SAS Superstructure**OSM Arrival Time:** 2300**Prime Contractor:** American Bridge/Fluor Enterprises, a JV**OSM Departure Time:** 730**Contractor:** Zhenhua Port Machinery Company, Ltd (ZPMC), Changxing Island **Location:** Changxing Island**CWI Name:** Chen Xi**CWI Present:** Yes No**Inspected CWI report:** Yes No N/A**Rod Oven in Use:** Yes No N/A**Electrode to specification:** Yes No N/A**Weld Procedures Followed:** Yes No N/A**Qualified Welders:** Yes No N/A**Verified Joint Fit-up:** Yes No N/A**Approved Drawings:** Yes No N/A**Approved WPS:** Yes No N/A**Delayed / Cancelled:** Yes No N/A**Bridge No:** 34-0006**Component:** OBG**Summary of Items Observed:**

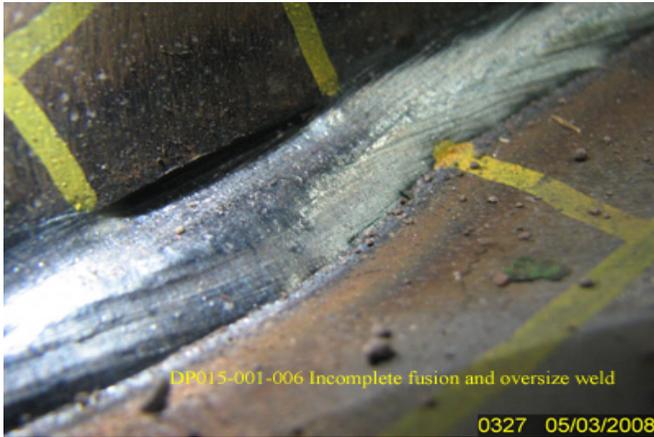
The Caltrans QA Inspector observed ZPMC welder Mr. Song Yin Shua performing Flux Cored Arc Welding (FCAW) on U-rib Complete Joint Penetration (CJP) splice welds DP437-001-190 and DP221-001-194 in the 3G position. Splice welds were back gouged to sound metal, ground smooth, and welding completed. The following parameters were recorded from weld DP437-001-190, amperage 207, voltage 25.1, travel speed of 107 mm/min., with a heat input of 2.91 kJ/mm. The above mentioned welding appeared to be in conformance with the posted welding procedure specification, WPS-B-T-2233-B-U2-F. Please see the attached photo of the above mentioned welding.
