Contract #: 04-0120F4Cty: SF/ALA Rte: 80 PM: 13.2/13.9File #: 69.28**WELDING INSPECTION REPORT****Resident Engineer:** Pursell, Gary**Address:** 333 Burma Road**City:** Oakland, CA 94607**Report No:** WIR-002641**Date Inspected:** 09-May-2008**Project Name:** SAS Superstructure**OSM Arrival Time:** 630**Prime Contractor:** American Bridge/Fluor Enterprises, a JV**OSM Departure Time:** 1530**Contractor:** Zhenhua Port Machinery Company, Ltd (ZPMC), Changxing Island **Location:** Shanghai, China**CWI Name:** See below**CWI Present:** Yes No**Inspected CWI report:** Yes No N/A**Rod Oven in Use:** Yes No N/A**Electrode to specification:** Yes No N/A**Weld Procedures Followed:** Yes No N/A**Qualified Welders:** Yes No N/A**Verified Joint Fit-up:** Yes No N/A**Approved Drawings:** Yes No N/A**Approved WPS:** Yes No N/A**Delayed / Cancelled:** Yes No N/A**Bridge No:** 34-0006**Component:** OBG/Tower**Summary of Items Observed:**

OBG/Tower Sub-Assembly**Bay 2 - 77 & 144 Meter Mock-up:**

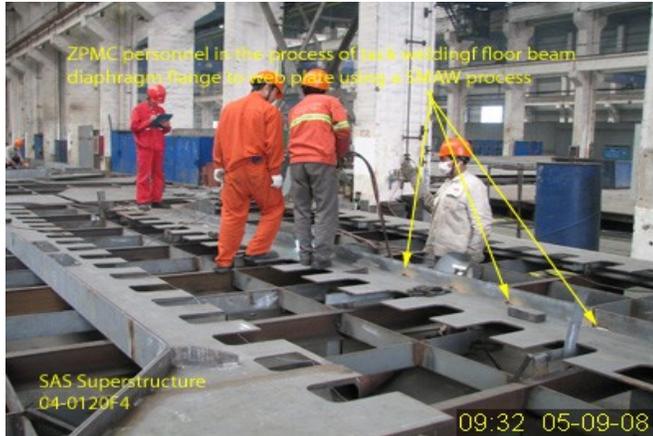
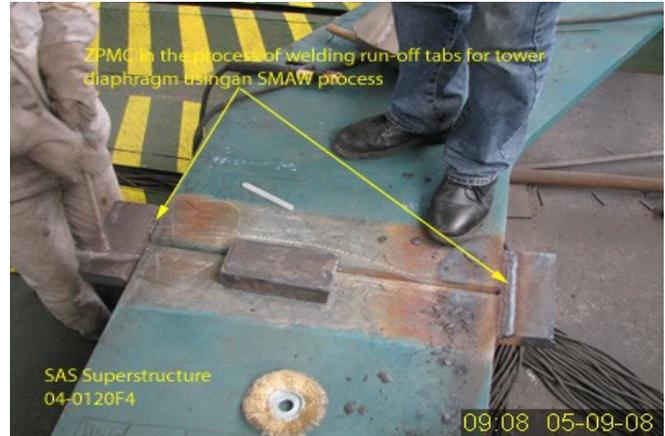
QA Inspector Brannon randomly observed ZPMC personnel assembling tower diaphragm flange for SA 219 and welding run off tabs.

The following digital photograph below illustrates observation of the activities being performed.
