Contract #: 04-0120F4Cty: SF/ALA Rte: 80 PM: 13.2/13.9File #: 69.28**WELDING INSPECTION REPORT****Resident Engineer:** Pursell, Gary**Address:** 333 Burma Road**City:** Oakland, CA 94607**Report No:** WIR-002668**Date Inspected:** 04-May-2008**Project Name:** SAS Superstructure**OSM Arrival Time:** 1400**Prime Contractor:** American Bridge/Fluor Enterprises, a JV**OSM Departure Time:** 2300**Contractor:** Zhenhua Port Machinery Company, Ltd (ZPMC), Changxing Island **Location:** Shanghai China**CWI Name:** Jiang Jian Hui**CWI Present:** Yes No**Inspected CWI report:** Yes No N/A**Rod Oven in Use:** Yes No N/A**Electrode to specification:** Yes No N/A**Weld Procedures Followed:** Yes No N/A**Qualified Welders:** Yes No N/A**Verified Joint Fit-up:** Yes No N/A**Approved Drawings:** Yes No N/A**Approved WPS:** Yes No N/A**Delayed / Cancelled:** Yes No N/A**Bridge No:** 34-0006**Component:** Tower**Summary of Items Observed:**

New Tower Shop

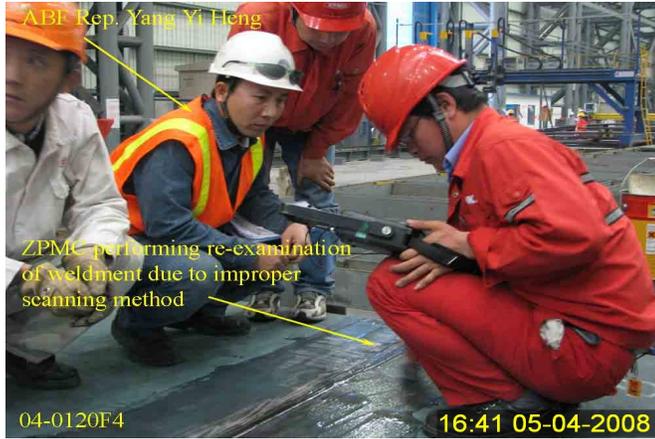
This Quality Assurance (QA) inspector arrived at ZPMC for observation of the SAS super structure fabrication. During his observation ZPMC was performing Ultrasonic Testing (UT) on skin plate splice ESD1-SA233 A/F weld 20a, during this observation it was noted that ZPMC UT technician Ma Jing Long was scanning beyond the required scanning pattern for complete coverage and speed that did not ensure proper sound coverage. This was brought to the attention of ZPMC CWI Jiang Jian Hui and ABF representative Yang Yi Heng. Mr. Heng spoke with ZPMC about this issue and had ZPMC re-scan the weldment with a proper scanning patterns and speed according to AWS D1.5. It was noted that ABF did inform ZPMC prior to the arrival of this QA inspector that they were not performing a proper scan and did not change their process until this QA inspector arrived and brought it to their attention. ZPMC UT technician Xue Hai Rong performed the re-examination of the above noted weldment and was observed by this QA inspector and the ABF representative noted above.

During the continued observations in the new tower shop it was noted that ZPMC was performing in process welding on several components using the Submerged Arc Welding (SAW) process for skin plate splices. The following are the components being welded; SSD1-SA159 D/J-2A welding operator Liu Zhen Hong and SSD1-SA17 A/G-17B welding operator Yun Chuan Jin. These areas were performed under WPS-B-T-2221-B-U3c-S with ZPMC's CWI Xu Le Fong monitoring welding parameters and welding progression along with 3 additional Quality Control personnel.
