Contract #: 04-0120F4Cty: SF/ALA Rte: 80 PM: 13.2/13.9File #: 69.28**WELDING INSPECTION REPORT****Resident Engineer:** Pursell, Gary**Address:** 333 Burma Road**City:** Oakland, CA 94607**Report No:** WIR-002727**Date Inspected:** 30-May-2008**Project Name:** SAS Superstructure**OSM Arrival Time:** 2330**Prime Contractor:** American Bridge/Fluor Enterprises, a JV**OSM Departure Time:** 700**Contractor:** Zhenhua Port Machinery Company, Ltd (ZPMC), Changxing Island **Location:** Shanghai China

WELDING INSPECTION REPORT

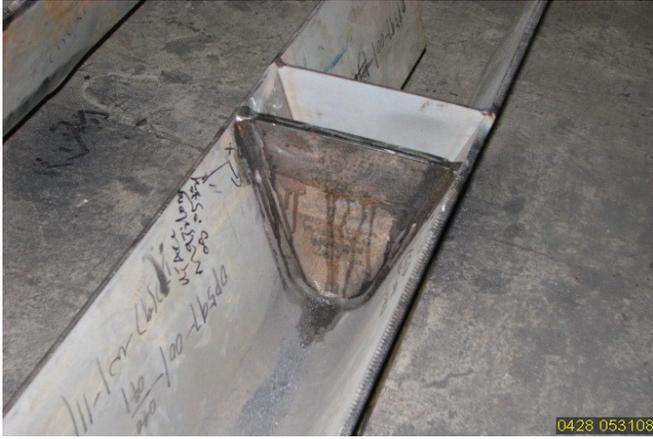
The Caltrans QA Inspector performed Ultrasonic Testing (UT) verification of the QC UT Inspected and accepted welds 114, 115, 121, 122 for DP597-001. QA Inspector's visual and UT verification appears to be acceptable with AWS D1.5-02 section 6, table 6.3. Reference QA Ultrasonic Test Report TL-6027 dated 5/30/08 for specific test data.

Item	Description	WBS	Dwg No.	Status
1	Above picture UT of the CJP closed rib diaphragm plate portion of the weld on DP597-001 welds 114, 115, 121 & 122.
