Quality Assurance and Source Inspection

Contract #: 04-0120F4Cty: SF/ALA Rte: 80 PM: 13.2/13.9File #: 69.28**WELDING INSPECTION REPORT****Resident Engineer:** Pursell, Gary**Address:** 333 Burma Road**City:** Oakland, CA 94607**Report No:** WIR-002759**Date Inspected:** 27-May-2008**Project Name:** SAS Superstructure**OSM Arrival Time:** 700**Prime Contractor:** American Bridge/Fluor Enterprises, a JV**OSM Departure Time:** 1700**Contractor:** Zhenhua Port Machinery Company, Ltd (ZPMC), Changxing Island **Location:** Shanghai, China**CWI Name:** Sun Wei**CWI Present:** Yes No**Inspected CWI report:** Yes No N/A**Rod Oven in Use:** Yes No N/A**Electrode to specification:** Yes No N/A**Weld Procedures Followed:** Yes No N/A**Qualified Welders:** Yes No N/A**Verified Joint Fit-up:** Yes No N/A**Approved Drawings:** Yes No N/A**Approved WPS:** Yes No N/A**Delayed / Cancelled:** Yes No N/A**Bridge No:** 34-0006**Component:** Tower and OBG**Summary of Items Observed:**

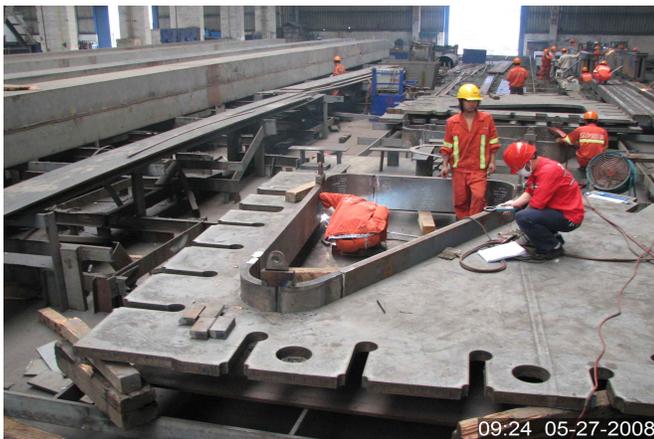
The Quality Assurance Inspector observed 5 sets of diaphragm flanges in various stages of fabrication from fit-up to in process welding. Below is a digital photograph illustrating ZPMC welding the run-off tabs in preparation for the complete joint penetration weld.

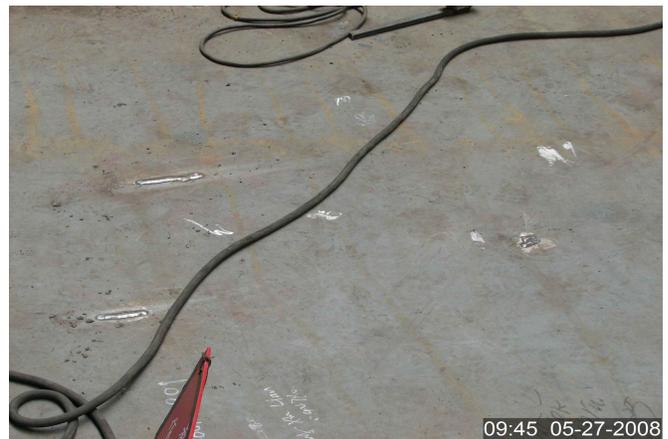
The Quality Assurance Inspector observed ZPMC performing base metal repairs to Floor Beam FB-036-001. The welding was being performed in accordance with welding procedure specification WPS-345-SMAW-1G-FCM-Repair. The Quality Assurance Inspector measured the depth of the ground excavations prior to welding to be a maximum of 2.5 millimeters. Below is a digital photograph illustrating the base metal repairs in progress.
