**DEPARTMENT OF TRANSPORTATION**

Contract #: 04-0120F4Cty: SF/ALA Rte: 80 PM: 13.2/13.9File #: 69.28**WELDING INSPECTION REPORT****Resident Engineer:** Pursell, Gary**Address:** 333 Burma Road**City:** Oakland, CA 94607**Report No:** WIR-002786**Date Inspected:** 03-Jun-2008**Project Name:** SAS Superstructure**OSM Arrival Time:** 2300**Prime Contractor:** American Bridge/Fluor Enterprises, a JV**OSM Departure Time:** 800**Contractor:** Zhenhua Port Machinery Company, Ltd (ZPMC), Changxing Island **Location:** Changxing Island**CWI Name:** Wang Sai Fa**CWI Present:** Yes No**Inspected CWI report:** Yes No N/A**Rod Oven in Use:** Yes No N/A**Electrode to specification:** Yes No N/A**Weld Procedures Followed:** Yes No N/A**Qualified Welders:** Yes No N/A**Verified Joint Fit-up:** Yes No N/A**Approved Drawings:** Yes No N/A**Approved WPS:** Yes No N/A**Delayed / Cancelled:** Yes No N/A**Bridge No:** 34-0006**Component:** OBG and Tower**Summary of Items Observed:**

# WELDING INSPECTION REPORT

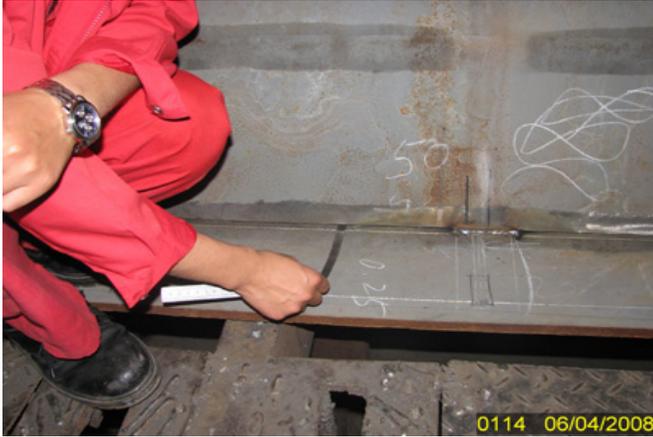
The Caltrans QA Inspector observed ZPMC welder Mr. Liu Xiaomin performing Gas Metal Arc Welding (GMAW) on Deck Panel DP591-001 tack welds. It was observed that weight and hydraulic jacks were utilized by ZPMC to achieve the .5 mm root gap required by the contract documents. It was also noted that ZPMC were preheating the weld area up to 90 degrees Celsius prior to welding. Welding appeared to be compliant with the posted Welding Procedure Specification WPS-B-T-2342-U2 (u-rib) and contract documents. The attached photo below shows ZPMC checking the root gap with a ¼ mm filler gauge.
