Contract #: 04-0120F4Cty: SF/ALA Rte: 80 PM: 13.2/13.9File #: 69.28**WELDING INSPECTION REPORT****Resident Engineer:** Pursell, Gary**Address:** 333 Burma Road**City:** Oakland, CA 94607**Report No:** WIR-002804**Date Inspected:** 19-Apr-2008**Project Name:** SAS Superstructure**OSM Arrival Time:** 1400**Prime Contractor:** American Bridge/Fluor Enterprises, a JV**OSM Departure Time:** 2300**Contractor:** Zhenhua Port Machinery Company, Ltd (ZPMC), Changxing Island **Location:** Shanghai, China**CWI Name:** Hu Wei Qing**CWI Present:** Yes No**Inspected CWI report:** Yes No N/A**Rod Oven in Use:** Yes No N/A**Electrode to specification:** Yes No N/A**Weld Procedures Followed:** Yes No N/A**Qualified Welders:** Yes No N/A**Verified Joint Fit-up:** Yes No N/A**Approved Drawings:** Yes No N/A**Approved WPS:** Yes No N/A**Delayed / Cancelled:** Yes No N/A**Bridge No:** 34-0006**Component:** OBG/Tower**Summary of Items Observed:**

WELDING INSPECTION REPORT

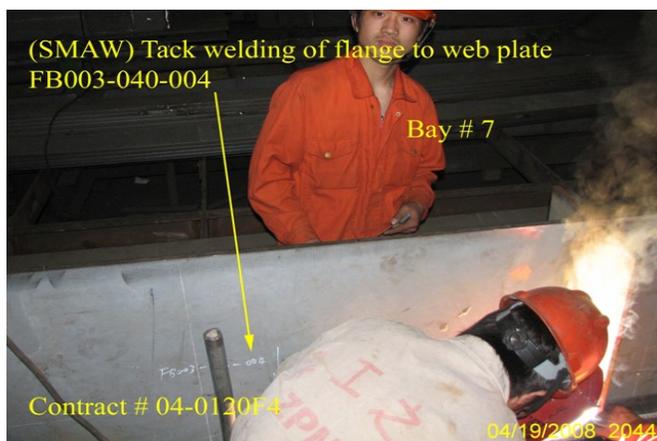
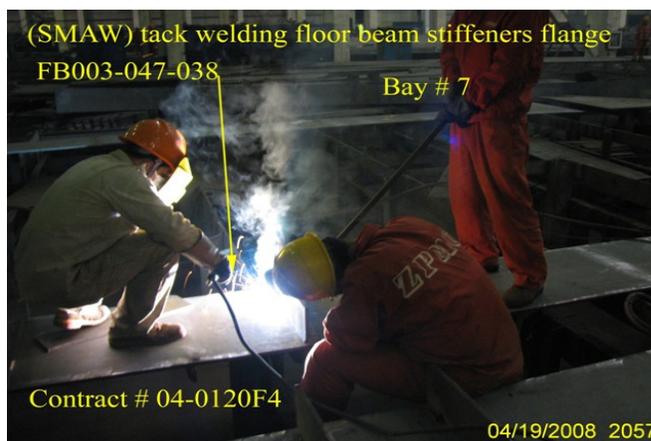
The QA Inspector randomly observed ZPMC qualified Welder Zhengang ID 049769 utilizing the Shielded Metal Arc Welding (SMAW) Process with ZPMC Weld Procedure Specification (WPS) WPS-B-P-2112-FCM to tack weld side plates SP476-001-001, and SP476-001-001.

These two above listed stiffeners were visually verified by the QA Inspector as being welded to Seismic Performance Critical Member (SPCM) plate material identified by ZPMC with the use of paint stick markings on the plate shown as (SPCM), PL606 SP476. The QA Inspector visually verified the filler metal being used to weld the stiffeners to the Seismic Performance Critical Member (SPCM) plate material as electrode THJ506Fe-11 with a diameter of 5.0mm.

During the tack welding of WT stiffener SP476-001-001 the QA Inspector verified the welding machine amperes utilizing a Fluke Meter.

For more detail see photographs shown below:
