DEPARTMENT OF TRANSPORTATION

Contract #: 04-0120F4Cty: SF/ALA Rte: 80 PM: 13.2/13.9File #: 69.28**WELDING INSPECTION REPORT****Resident Engineer:** Pursell, Gary**Address:** 333 Burma Road**City:** Oakland, CA 94607**Report No:** WIR-002817**Date Inspected:** 02-Jun-2008**Project Name:** SAS Superstructure**OSM Arrival Time:** 700**Prime Contractor:** American Bridge/Fluor Enterprises, a JV**OSM Departure Time:** 1700**Contractor:** Zhenhua Port Machinery Company, Ltd (ZPMC), Changxing Island **Location:** Shanghai, China**CWI Name:** C.H. Chen**CWI Present:** Yes No**Inspected CWI report:** Yes No N/A**Rod Oven in Use:** Yes No N/A**Electrode to specification:** Yes No N/A**Weld Procedures Followed:** Yes No N/A**Qualified Welders:** Yes No N/A**Verified Joint Fit-up:** Yes No N/A**Approved Drawings:** Yes No N/A**Approved WPS:** Yes No N/A**Delayed / Cancelled:** Yes No N/A**Bridge No:** 34-0006**Component:** Tower Partial Mock-ups**Summary of Items Observed:**

Tower 77 Meter Partial Mock-Ups Welding Trials

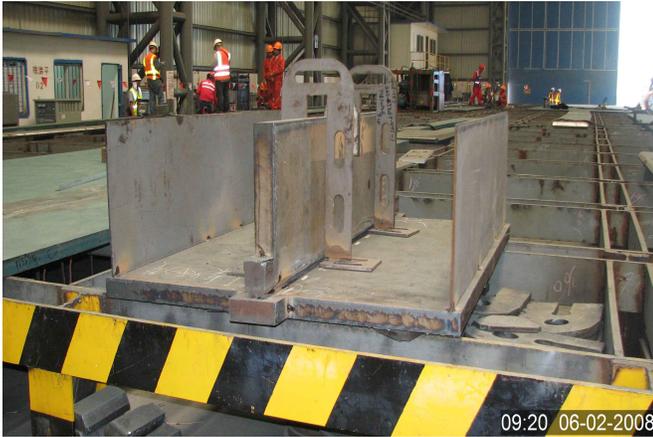
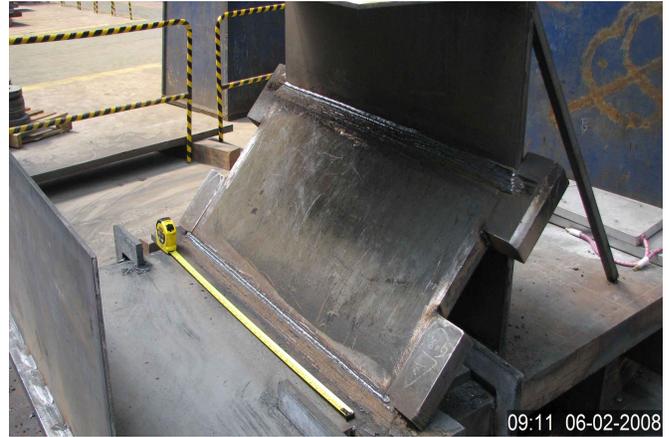
WT-101, the Caltrans QA Inspector was informed that ABF has requested that ZPMC re-fit this assembly due to poor quality tack welds and also the mill scale present in the groove weld area of the partial joint penetration weld.

The Quality Assurance Inspector performed an inspection of the fit-up and observed what appeared to be poor penetration of the tack welds. In addition the Quality Assurance Inspector measured the bevel angle and the bevel depth of the partial joint penetration weld. Below is a digital photograph of the assembly and a close up photograph of the bevel depth being approximately 29 millimeters as detailed.
