DEPARTMENT OF TRANSPORTATION

Contract #: 04-0120F4Cty: SF/ALA Rte: 80 PM: 13.2/13.9File #: 70.28**WELDING INSPECTION REPORT****Resident Engineer:** Pursell, Gary**Address:** 333 Burma Road**City:** Oakland, CA 94607**Report No:** WIR-002820**Date Inspected:** 30-May-2008**Project Name:** SAS Superstructure**OSM Arrival Time:** 900**Prime Contractor:** American Bridge/Fluor Enterprises, a JV**OSM Departure Time:** 1830**Contractor:** Japan Steel Works**Location:** Muroan, Japan**CWI Name:** Chung-Fu Kuan**CWI Present:** Yes No**Inspected CWI report:** Yes No N/A**Rod Oven in Use:** Yes No N/A**Electrode to specification:** Yes No N/A**Weld Procedures Followed:** Yes No N/A**Qualified Welders:** Yes No N/A**Verified Joint Fit-up:** Yes No N/A**Approved Drawings:** Yes No N/A**Approved WPS:** Yes No N/A**Delayed / Cancelled:** Yes No N/A**Bridge No:** 34-0006**Component:** Tower, Jacking and Deviation Saddles**Summary of Items Observed:**

The following report is based on METS observations at Japan Steel Works (JSW) in Muroan Japan. Current work: Casting, machining and nondestructive testing of Saddles.

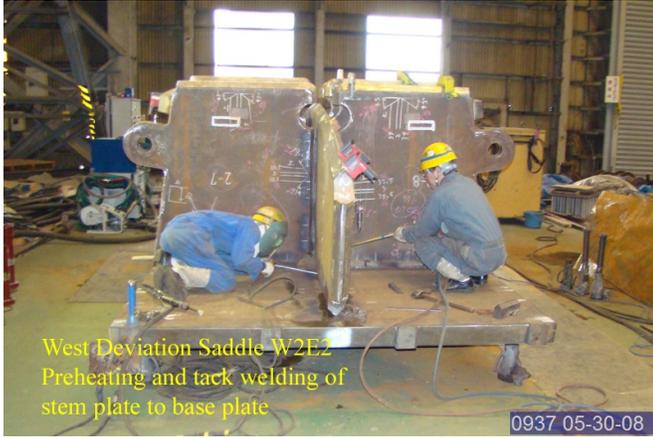
On this date the Caltrans Quality Assurance (QA) inspector, Joe Lanz arrived at JSW fabrication shop number 4 and observed the in process tack welding operation of the structural steel plates for the West Deviation Saddle base W2E1. The tack welding was performed at the stem to rib weld locations on the opposite side of rib plates from existing tack welds. The joint designations were E1Y-6V, E1Y-8V, E1Y-10V, E1Y-12V E1Y-14V and E1Y-16V. The JSW welding personnel Tatsuya Naitoh, identified as number 71-2736 and K. Kabayashi, identified as 08-5023 performed the welding utilizing the Shielded Metal Arc Welding (SMAW) process per the welding procedure specifications (WPS) SJ-3011-3. The welding was performed in the 2G (Horizontal) position. The filler metal utilized was identified as 4.8mm diameter, Class E9018-M-H4R, Brand name Hoballoy 9018-M. The preheating was performed by two JSW fitter personnel utilizing an oxygen fuel gas torch. The welding parameters and heat control were monitored by Intertek Testing Services Quality Control (QC) inspector Mr. Chung-Fu Kuan at periodic intervals. The minimum preheat temperature of 160 degrees Celsius and maximum interpass temperature of 260 degrees Celsius was verified to meet the WPS requirements by Mr. Kuan and the QA inspector utilizing Tempilstik temperature indicators. This data was entered into the QC inspector's daily log, identifying the location on a weld map. The SMAW welding average amperage and voltage by clamp type meter and travel speed were verified to be within the welding procedure specification parameter range of 245 amps to 270 amps, 22 volts to 25 volts and travel speed of 132 to 168 mm per minute for the 4.8mm electrode by the QA

On this date the Caltrans Quality Assurance (QA) inspector, Joe Lanz arrived at JSW fabrication shop number 4 and observed the in process tack welding operation of the structural steel plates for the West Deviation Saddle base W2E2. The tack welding was performed at the stem to rib weld locations on the opposite side of rib plates from existing tack welds. The JSW fitter personnel Kiyotaka Koanagi continued assembly of the West Deviation Saddle base W2E2 by aligning the rib plates, piece marks 2-11 and 2-12 on the base plate, joint designations E2Y-11L and E2Y-12L and aligning with the stem plate, joint designations E2Y-11V and E2Y-12V. The JSW welding personnel Yoshihiro Ohta, identified as number 08-2017 performed the in process tack welding utilizing the Shielded Metal Arc Welding (SMAW) process per the welding procedure specifications (WPS) SJ-3011-2 and SJ-3011-3. The welding was performed in the 2G (Horizontal) and 3G (Vertical) positions. The filler metal utilized was identified as 4.0mm and 4.8mm diameter, Class E9018-M-H4R, Brand name Hoballoy 9018-M. The welding parameters and heat control were monitored by Intertek Testing Services Quality Control (QC) inspector Mr. Chung-Fu Kuan at periodic intervals. The minimum preheat temperature of 160 degrees Celsius and maximum interpass temperature of 260 degrees Celsius was verified to meet the WPS requirements by Mr. Kuan and the QA inspector utilizing Tempilstik temperature indicators. This data was entered into the QC inspector's daily log, identifying the location on a weld map. The SMAW welding average amperage and voltage by clamp type meter and travel speed were verified to be within the welding procedure specification parameter range of 245 amps to 270 amps, 22 volts to 25 volts and travel speed of 132 to 168 mm per minute for the 4.8mm electrode and 145 amps to 165 amps, 21 volts to 24 volts and travel speed of 72 to 97 mm per minute for the 4.0mm electrode by the QA inspector. The work was not completed on this date and appears to meet the minimum requirements of the welding procedure specification and contract documents.

The following digital photographs illustrate observations of the activities being performed.
