DEPARTMENT OF TRANSPORTATION

Quality Assurance and Source Inspection

Contract #: 04-0120F4Cty: SF/ALA Rte: 80 PM: 13.2/13.9File #: 69.28**WELDING INSPECTION REPORT****Resident Engineer:** Pursell, Gary**Address:** 333 Burma Road**City:** Oakland, CA 94607**Report No:** WIR-002866**Date Inspected:** 11-Jun-2008**Project Name:** SAS Superstructure**OSM Arrival Time:** 1400**Prime Contractor:** American Bridge/Fluor Enterprises, a JV**OSM Departure Time:** 2300**Contractor:** Zhenhua Port Machinery Company, Ltd (ZPMC), Changxing Island **Location:** Shanghai, China

Bridge No: 34-0006**Component:** OBG side, bottom and deck panels**Summary of Items Observed:**

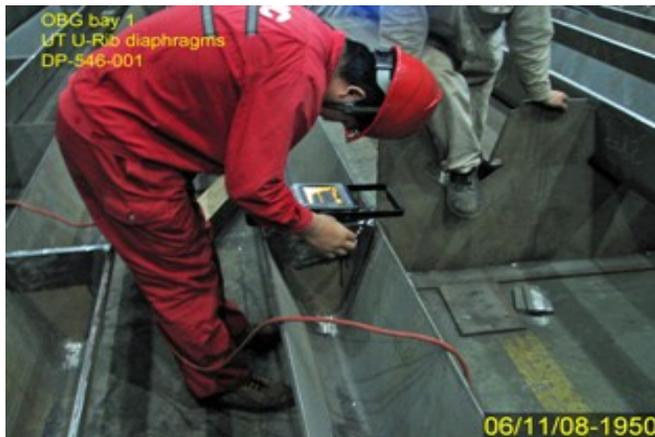
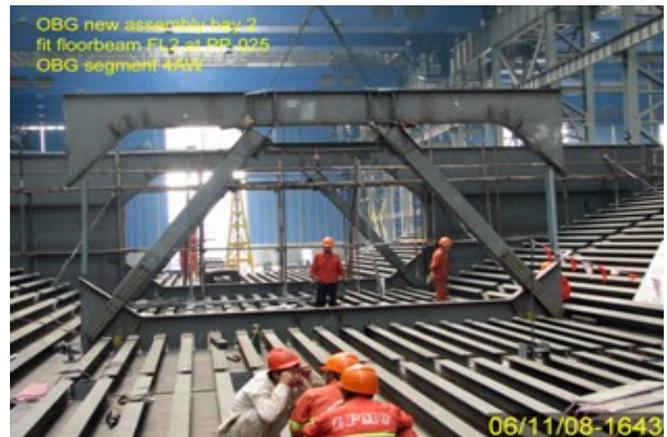
QA observed ZPMC has approximately 45 workers performing various functions relative to the fabrication of the OBG Deck Panels. These functions include; closed rib press forming, hole drilling at ends of U-Ribs using a drill template, PJP bevel preparation, closed rib splice FCAW welding, closed rib diaphragm fit-up and FCAW welding, closed rib to deck plate fit-up and tack welding.
