Contract #: 04-0120F4Cty: SF/ALA Rte: 80 PM: 13.2/13.9File #: 69.28**WELDING INSPECTION REPORT****Resident Engineer:** Pursell, Gary**Address:** 333 Burma Road**City:** Oakland, CA 94607**Report No:** WIR-002912**Date Inspected:** 15-Jun-2008**Project Name:** SAS Superstructure**OSM Arrival Time:** 630**Prime Contractor:** American Bridge/Fluor Enterprises, a JV**OSM Departure Time:** 1430**Contractor:** Zhenhua Port Machinery Company, Ltd (ZPMC), Changxing Island **Location:** Shanghai, China**CWI Name:** Wang Sei Fa**CWI Present:** Yes No**Inspected CWI report:** Yes No N/A**Rod Oven in Use:** Yes No N/A**Electrode to specification:** Yes No N/A**Weld Procedures Followed:** Yes No N/A**Qualified Welders:** Yes No N/A**Verified Joint Fit-up:** Yes No N/A**Approved Drawings:** Yes No N/A**Approved WPS:** Yes No N/A**Delayed / Cancelled:** Yes No N/A**Bridge No:** 34-0006**Component:** OBG Deck Panel Repairs**Summary of Items Observed:**

WELDING INSPECTION REPORT

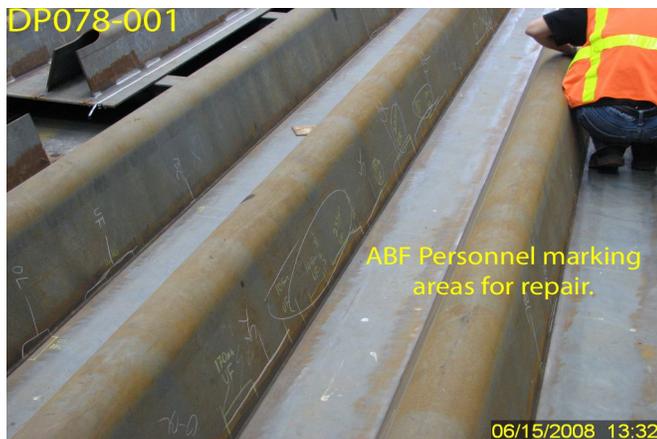
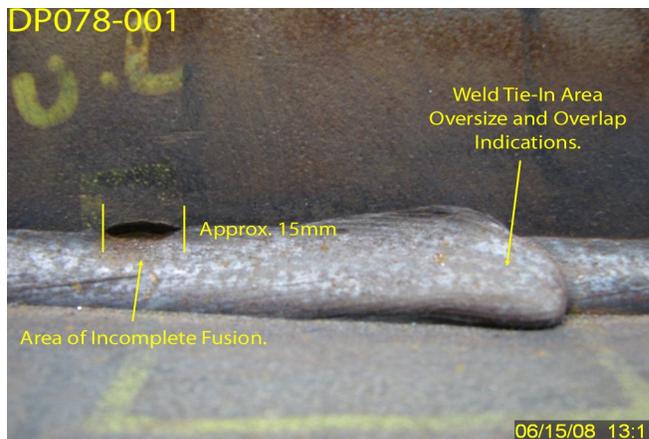
This QA Inspector performed an initial visual confirmation of the extent of rejectable indications contained in deck panel designated as DP078-001. This visual confirmation was performed in conjunction with ABF representative Warren Buehler and ZPMC representative Wang Sei Fa.
