DEPARTMENT OF TRANSPORTATION

Quality Assurance and Source Inspection

Contract #: 04-0120F4Cty: SF/ALA Rte: 80 PM: 13.2/13.9File #: 69.28**WELDING INSPECTION REPORT****Resident Engineer:** Pursell, Gary**Address:** 333 Burma Road**City:** Oakland, CA 94607**Report No:** WIR-002972**Date Inspected:** 13-Jun-2008**Project Name:** SAS Superstructure**OSM Arrival Time:** 700**Prime Contractor:** American Bridge/Fluor Enterprises, a JV**OSM Departure Time:** 1700**Contractor:** Zhenhua Port Machinery Company, Ltd (ZPMC), Changxing Island **Location:** Shanghai, China**CWI Name:** Sun Wei**CWI Present:** Yes No**Inspected CWI report:** Yes No N/A**Rod Oven in Use:** Yes No N/A**Electrode to specification:** Yes No N/A**Weld Procedures Followed:** Yes No N/A**Qualified Welders:** Yes No N/A**Verified Joint Fit-up:** Yes No N/A**Approved Drawings:** Yes No N/A**Approved WPS:** Yes No N/A**Delayed / Cancelled:** Yes No N/A**Bridge No:** 34-0006**Component:** OBG and Tower**Summary of Items Observed:**

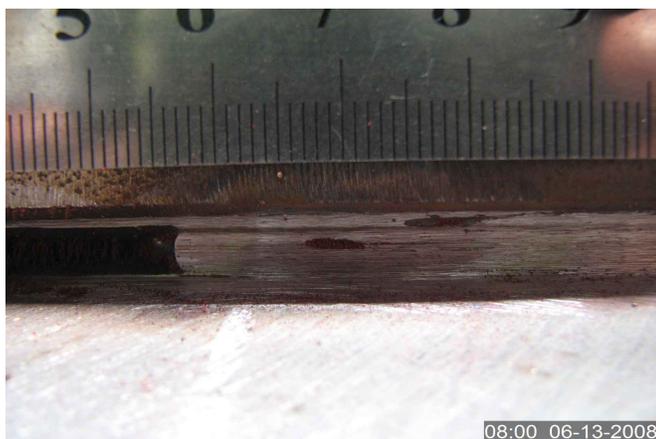
The Quality Assurance Inspector performed magnetic particle verification to 100 percent of the GMAW tack welds on welds 1 and 8 of Deck Panel DP-546-001 after ZPMC relayed that all the indications have been repaired and retested. Of the 50 tack welds tested the Quality Assurance Inspector observed 2 that still contained linear crack like indications. The Indications were ground and retested. Below is a digital photograph illustrating one of the cracked tack welds.

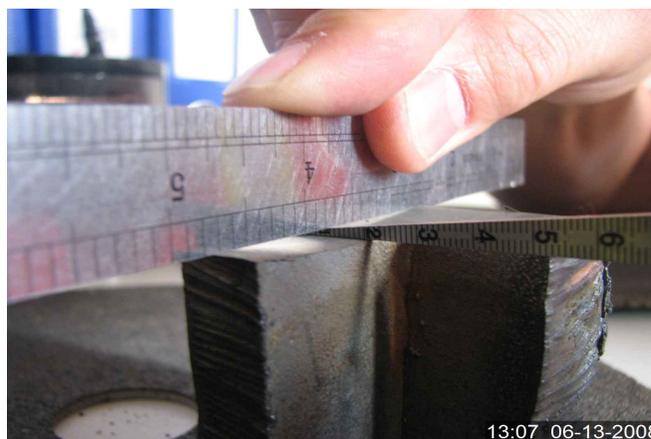
The Quality Assurance Inspector performed a visual inspection of two sets of production monitoring tests (PMT) macro etch samples, identified as DP-546-001 and DP-586-001. All samples appeared to contain penetration greater than 80 percent. Sample 546-1-1 was ground approximately 1 mm as illustrated in the digital photograph below. ZPMC relayed that an anomaly was present and after further grinding the anomaly was no longer present. All the data from the review was recorded in a tracking log and on the internal server for future review.
