DEPARTMENT OF TRANSPORTATION

Quality Assurance and Source Inspection

Contract #: 04-0120F4Cty: SF/ALA Rte: 80 PM: 13.2/13.9File #: 99.28**WELDING INSPECTION REPORT****Resident Engineer:** Pursell, Gary**Address:** 333 Burma Road**City:** Oakland, CA 94607**Report No:** WIR-002984**Date Inspected:** 14-Jun-2008**Project Name:** SAS Superstructure**OSM Arrival Time:** 2230**Prime Contractor:** American Bridge/Fluor Enterprises, a JV**OSM Departure Time:** 830**Contractor:** Japan Steel Works, Ltd.**Location:** Muroran, Japan**CWI Name:** Makhmud Ashadi**CWI Present:** Yes No**Inspected CWI report:** Yes No N/A**Rod Oven in Use:** Yes No N/A**Electrode to specification:** Yes No N/A**Weld Procedures Followed:** Yes No N/A**Qualified Welders:** Yes No N/A**Verified Joint Fit-up:** Yes No N/A**Approved Drawings:** Yes No N/A**Approved WPS:** Yes No N/A**Delayed / Cancelled:** Yes No N/A**Bridge No:** 34-0006**Component:** Tower, Jacking and Deviation Saddles**Summary of Items Observed:**

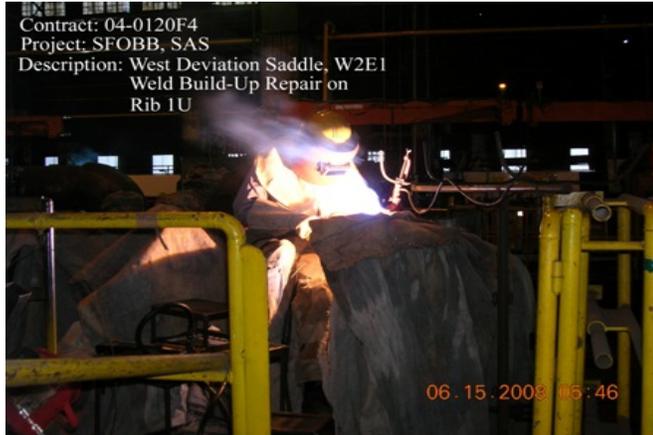
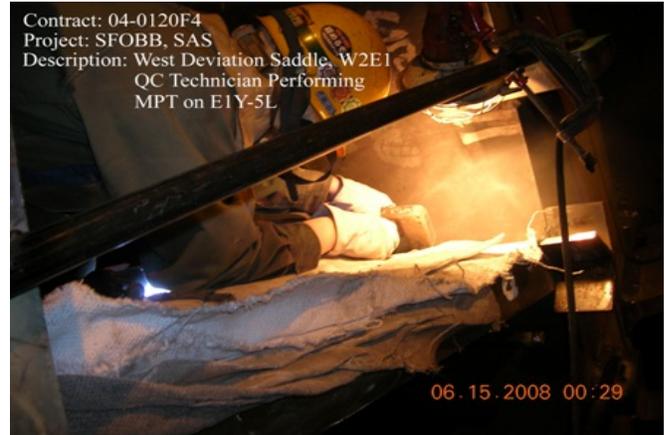
The welding, inspection, verification and MPT were performed on the weld joints identified as E1Y-5L and 5V, E1Y-6L and 6V and E1Y-11L and 12L. The welding was performed in the Flat Position (1G) with the work in the horizontal plane and the weld metal deposited from above.

This QA inspector randomly observed the in process Shielded Metal Arc Welding (SMAW) for the repair welding of the ribs. This QA inspector noted that it appeared the approved and latest revised WPS's were posted at the appropriate welding station and that each approved welder was entered in the latest revised Welding Personnel Log issued by Japan Steel Works, Ltd. The welding parameters, preheat and interpass temperatures were verified as noted by this QA inspector utilizing a Fluke 337 clamp meter for the electrical welding parameters and Tempilstik temperature indicators for preheat and interpass temperatures. The filler metal utilized at the welding stations was also verified. The welding was not completed during this shift and appeared to be in general compliance with the contract documents.

The following digital photographs illustrate the observations of the activities performed on this date.
