**DEPARTMENT OF TRANSPORTATION**

Contract #: 04-0120F4Cty: SF/ALA Rte: 80 PM: 13.2/13.9File #: 69.28**WELDING INSPECTION REPORT****Resident Engineer:** Pursell, Gary**Address:** 333 Burma Road**City:** Oakland, CA 94607**Report No:** WIR-003137**Date Inspected:** 01-Jul-2008**Project Name:** SAS Superstructure**OSM Arrival Time:** 2300**Prime Contractor:** American Bridge/Fluor Enterprises, a JV**OSM Departure Time:** 730**Contractor:** Zhenhua Port Machinery Company, Ltd (ZPMC), Changxing Island **Location:** Changxing Island**CWI Name:** Chen Xi**CWI Present:** Yes No**Inspected CWI report:** Yes No N/A**Rod Oven in Use:** Yes No N/A**Electrode to specification:** Yes No N/A**Weld Procedures Followed:** Yes No N/A**Qualified Welders:** Yes No N/A**Verified Joint Fit-up:** Yes No N/A**Approved Drawings:** Yes No N/A**Approved WPS:** Yes No N/A**Delayed / Cancelled:** Yes No N/A**Bridge No:** 34-0006**Component:** OBG**Summary of Items Observed:**

Caltrans Quality Assurance (QA) Inspector, Larry Viars was present to monitor activities associated with the Production Monitoring Test of Orthotropic Box Girder (OBG) Deck Panel U-rib welds, for the San Francisco Oakland Bay Self Ancho

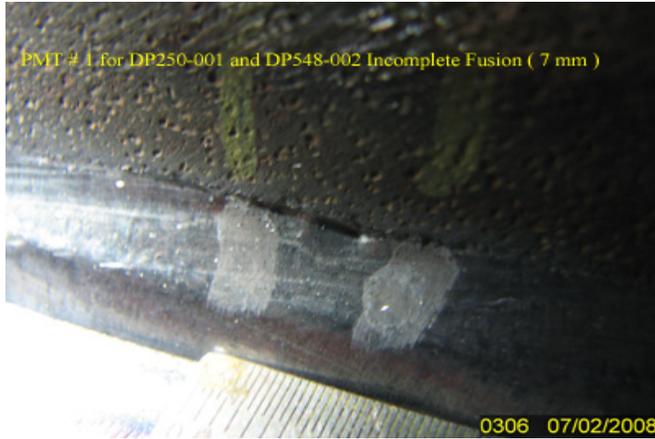
The Caltrans QA Inspector monitored the OBG Production Monitoring Test (PMT) for Deck Panels DP250-001 and DP548-002. The Caltrans QA inspector recorded amperage, voltage and travel speed of the Gas metal Arc Welding (GMAW) root pass and the Submerged Arc Welding (SAW) cover pass. A Visual inspection of the root pass and cover pass was performed by ZPMC, American Bridge Flour (ABF) and the Caltrans QA. The Caltrans QA observed ZPMC QC Mr. Ma Jilong perform Ultrasonic testing of the Partial Joint Penetration weld for depth of penetration. Mr. Ma found the depth of penetration of the PMT welds to be in compliance with contract documents. The Caltrans QA inspector designated locations for Macroetch samples (15 locations). Macroetch samples were evaluated with a 7x optical comparator and accepted by ZPMC QC, ABF QC and The Caltrans QA Inspector. Please see the attached photos of Incomplete Fusion on the SAW cover pass of weld # 6.
