DEPARTMENT OF TRANSPORTATION

Quality Assurance and Source Inspection

Contract #: 04-0120F4Cty: SF/ALA Rte: 80 PM: 13.2/13.9File #: 69.28**WELDING INSPECTION REPORT****Resident Engineer:** Pursell, Gary**Address:** 333 Burma Road**City:** Oakland, CA 94607**Report No:** WIR-003216**Date Inspected:** 16-Jul-2008**Project Name:** SAS Superstructure**OSM Arrival Time:** 630**Prime Contractor:** American Bridge/Fluor Enterprises, a JV**OSM Departure Time:** 1530**Contractor:** Zhenhua Port Machinery Company, Ltd (ZPMC), Changxing Island **Location:** Shanghai, China**CWI Name:** C.M. Chen**CWI Present:** Yes No**Inspected CWI report:** Yes No N/A**Rod Oven in Use:** Yes No N/A**Electrode to specification:** Yes No N/A**Weld Procedures Followed:** Yes No N/A**Qualified Welders:** Yes No N/A**Verified Joint Fit-up:** Yes No N/A**Approved Drawings:** Yes No N/A**Approved WPS:** Yes No N/A**Delayed / Cancelled:** Yes No N/A**Bridge No:** 34-0006**Component:** OBG**Summary of Items Observed:**

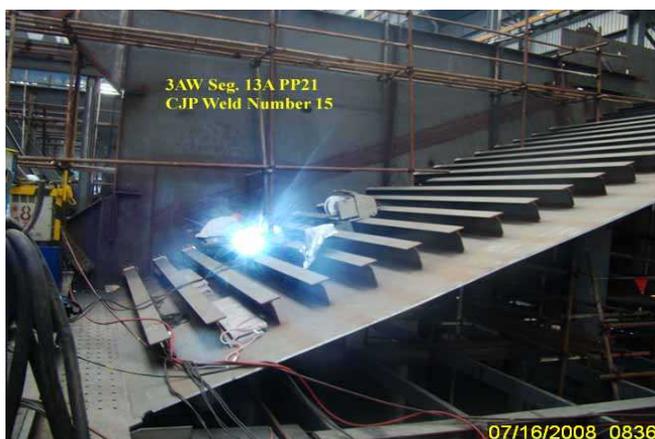
OBG Assembly Segment 3AW- Caltrans QA observed ZPMC personnel depositing FCAW filler metal on CJP weld connecting Floor Beam FL3 to the Side Panel E7 (Weld number 15) located at Seg. 13A PP21. Caltrans QA also observed ZPMC personnel depositing SMAW filler metal to the "B" side, on CJP weld connecting Seg. 13A Side Panel E7 to Bottom Panel D6, Weld Number 11.
