Contract #: 04-0120F4Cty: SF/ALA Rte: 80 PM: 13.2/13.9File #: 69.28**WELDING INSPECTION REPORT****Resident Engineer:** Pursell, Gary**Address:** 333 Burma Road**City:** Oakland, CA 94607**Report No:** WIR-003234**Date Inspected:** 08-Jul-2008**Project Name:** SAS Superstructure**OSM Arrival Time:** 1400**Prime Contractor:** American Bridge/Fluor Enterprises, a JV**OSM Departure Time:** 2300**Contractor:** Zhenhua Port Machinery Company, Ltd (ZPMC), Changxing Island **Location:** Shanghai China

**Bridge No:** 34-0006**Component:** OBG side, bottom and deck panels**Summary of Items Observed:**

## WELDING INSPECTION REPORT

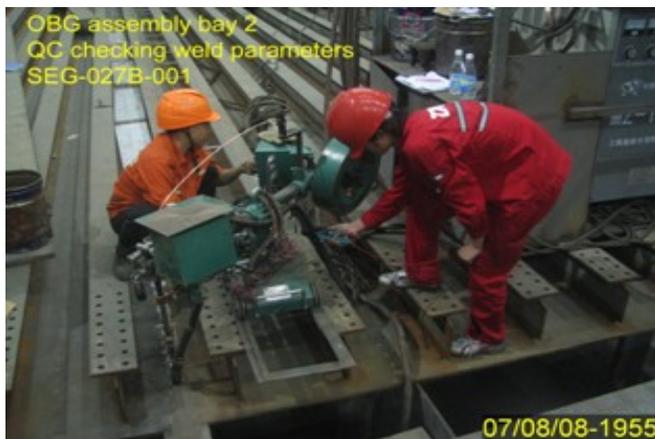
QA performed 10% verification MT on the following side panel welds on OBG section 4BW: SP-049 welds 15 thru 28. All welds examined appeared to conform to AWS D1.5 2002 and the contract documents.
