Contract #: 04-0120F4Cty: SF/ALA Rte: 80 PM: 13.2/13.9File #: 69.28**WELDING INSPECTION REPORT****Resident Engineer:** Pursell, Gary**Address:** 333 Burma Road**City:** Oakland, CA 94607**Report No:** WIR-003343**Date Inspected:** 26-Jul-2008**Project Name:** SAS Superstructure**OSM Arrival Time:** 700**Prime Contractor:** American Bridge/Fluor Enterprises, a JV**OSM Departure Time:** 1500**Contractor:** Zhenhua Port Machinery Company, Ltd (ZPMC), Changxing Island **Location:** Shanghai, China**CWI Name:** Sun Wei**CWI Present:** Yes No**Inspected CWI report:** Yes No N/A**Rod Oven in Use:** Yes No N/A**Electrode to specification:** Yes No N/A**Weld Procedures Followed:** Yes No N/A**Qualified Welders:** Yes No N/A**Verified Joint Fit-up:** Yes No N/A**Approved Drawings:** Yes No N/A**Approved WPS:** Yes No N/A**Delayed / Cancelled:** Yes No N/A**Bridge No:** 34-0006**Component:** OBG**Summary of Items Observed:**

WELDING INSPECTION REPORT

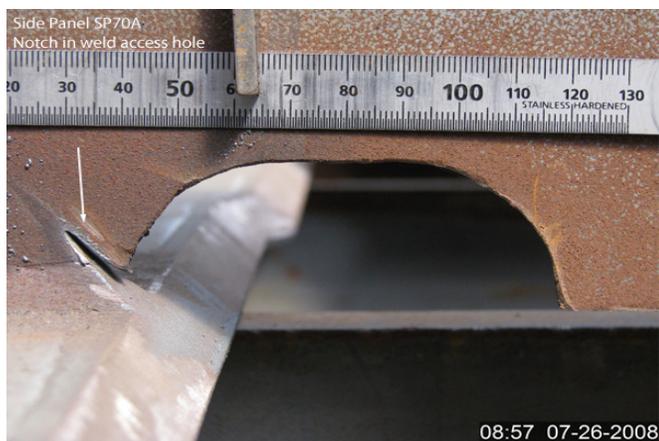
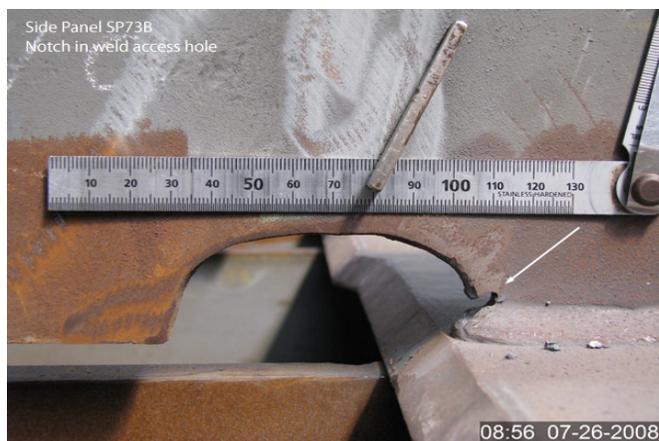
Segment 3AW – The Quality Assurance Inspector observed base metal damage at the webs of the “T” stiffeners at Side Panels SP-70A and SP-73B. It appears the damage occurred while thermal cutting the adjacent bevel. In addition, ABF Representative Josh Read “green tagged” the parts implying the panels were completed. The Quality Assurance Inspector informed Mr. Read. Mr. Read stated he must have overlooked the damage, would remove the “green tag”, and request ZPMC to generate a critical weld repair report for approval prior to repairing the parts. Below are digital photographs illustrating the discrepancies.
