DEPARTMENT OF TRANSPORTATION

Quality Assurance and Source Inspection

Contract #: 04-0120F4Cty: SF/ALA Rte: 80 PM: 13.2/13.9File #: 70.28**WELDING INSPECTION REPORT****Resident Engineer:** Pursell, Gary**Address:** 333 Burma Road**City:** Oakland, CA 94607**Report No:** WIR-003344**Date Inspected:** 30-Jul-2008**Project Name:** SAS Superstructure**OSM Arrival Time:** 2300**Prime Contractor:** American Bridge/Fluor Enterprises, a JV**OSM Departure Time:** 700**Contractor:** Japan Steel Works**Location:** Muroran, Japan**CWI Name:** Makhmud Ashadi**CWI Present:** Yes No**Inspected CWI report:** Yes No N/A**Rod Oven in Use:** Yes No N/A**Electrode to specification:** Yes No N/A**Weld Procedures Followed:** Yes No N/A**Qualified Welders:** Yes No N/A**Verified Joint Fit-up:** Yes No N/A**Approved Drawings:** Yes No N/A**Approved WPS:** Yes No N/A**Delayed / Cancelled:** Yes No N/A**Bridge No:** 34-0006**Component:** Tower, Deviation and Jacking Saddles**Summary of Items Observed:**

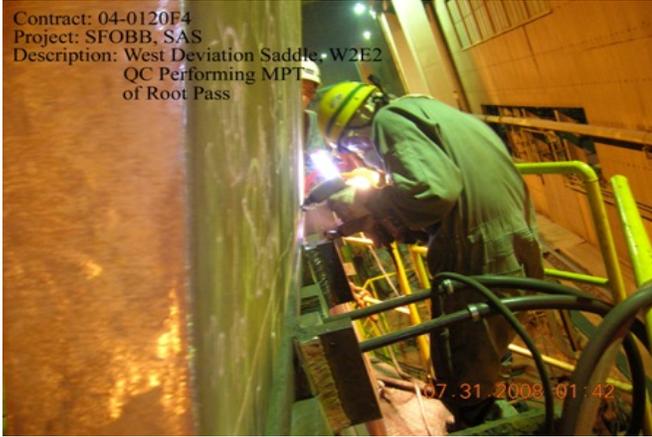
At the start of the shift the QA inspector traveled to the Fabrication Shop # 4 to observe the work scheduled on this shift for the West Deviation Saddle identified as W2E2. Upon arrival at the fabrication shop the QA inspector observed the in process welding and the Magnetic Particle Testing (MPT) of the Partial Joint Penetration (PJP) groove welds. The welding process utilized appeared to be the Shielded Metal Arc Welding (SMAW) and was performed by Japan Steel Works, Ltd. (JSW) welding personnel Yuichi-Arai ID 08-5157. The Welding Procedure Specification (WPS) utilized by the welder appeared to be SJ-3011-2 which was also used by the Intertek Testing Service (ITS) Quality Control (QC) Inspector Makhmud Ashadi as a reference during verification of the welding parameters. It was also noted by the QA inspector that JSW Distortion Control Plan identified as Document No. SJ-3109 Rev. 1 was utilized in conjunction with the WPS. The welding of the PJP groove weld was performed on the structural steel end plate to base plate connection identified as weld numbers E2Y-17L-1 and E2Y-17L-2 which appeared to comply with the AWS D1.5-2002 joint designation TC-P5. The welding was performed on the stamped side of the end plates.

The digital photograph on Page 3 of this report, illustrates the observations of the activities performed on this date.
