Contract #: 04-0120F4Cty: SF/ALA Rte: 80 PM: 13.2/13.9File #: 69.28**WELDING INSPECTION REPORT****Resident Engineer:** Pursell, Gary**Address:** 333 Burma Road**City:** Oakland, CA 94607**Report No:** WIR-003386**Date Inspected:** 30-Jul-2008**Project Name:** SAS Superstructure**OSM Arrival Time:** 1400**Prime Contractor:** American Bridge/Fluor Enterprises, a JV**OSM Departure Time:** 2300**Contractor:** Zhenhua Port Machinery Company, Ltd (ZPMC), Changxing Island **Location:** Shanghai, China**CWI Name:** Chen Chih-Ming/Li Jia**CWI Present:** Yes No**Inspected CWI report:** Yes No N/A**Rod Oven in Use:** Yes No N/A**Electrode to specification:** Yes No N/A**Weld Procedures Followed:** Yes No N/A**Qualified Welders:** Yes No N/A**Verified Joint Fit-up:** Yes No N/A**Approved Drawings:** Yes No N/A**Approved WPS:** Yes No N/A**Delayed / Cancelled:** Yes No N/A**Bridge No:** 34-0006**Component:** OBG side, bottom and deck panels and tower**Summary of Items Observed:**

WELDING INSPECTION REPORT

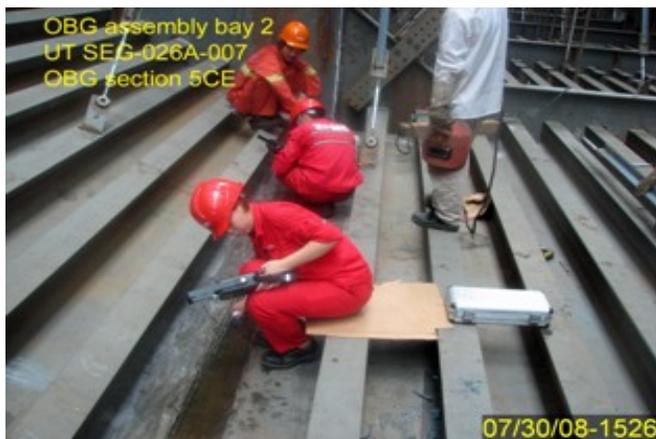
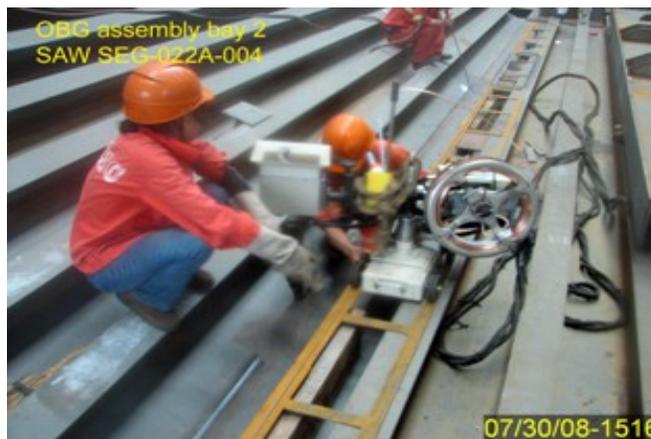
QA observed ZPMC QC Ultrasonic Testing (UT) technicians UT the following CJP welds on OBG section 5CE/D6: SEG-026A-007 (SP-604 to BP-166) and SEG-026A-008 (SP-360 to BP-112). Neither weld was UT'ed completely by ZPMC on this day.

Other general observations include ZPMC personnel fitting and welding OBG east fixture, OBG temporary support columns, grinding and weld bevel prep on various OBG components.
