Contract #: 04-0120F4Cty: SF/ALA Rte: 80 PM: 13.2/13.9File #: 70.28**WELDING INSPECTION REPORT****Resident Engineer:** Pursell, Gary**Address:** 333 Burma Road**City:** Oakland, CA 94607**Report No:** WIR-003396**Date Inspected:** 07-Aug-2008**Project Name:** SAS Superstructure**OSM Arrival Time:** 800**Prime Contractor:** American Bridge/Fluor Enterprises, a JV**OSM Departure Time:** 1630**Contractor:** Japan Steel Works**Location:** Muroran, Japan**CWI Name:** M. Ashadi**CWI Present:** Yes No**Inspected CWI report:** Yes No N/A**Rod Oven in Use:** Yes No N/A**Electrode to specification:** Yes No N/A**Weld Procedures Followed:** Yes No N/A**Qualified Welders:** Yes No N/A**Verified Joint Fit-up:** Yes No N/A**Approved Drawings:** Yes No N/A**Approved WPS:** Yes No N/A**Delayed / Cancelled:** Yes No N/A**Bridge No:** 34-0006**Component:** Tower, Deviation and Jacking Saddles**Summary of Items Observed:**

WELDING INSPECTION REPORT

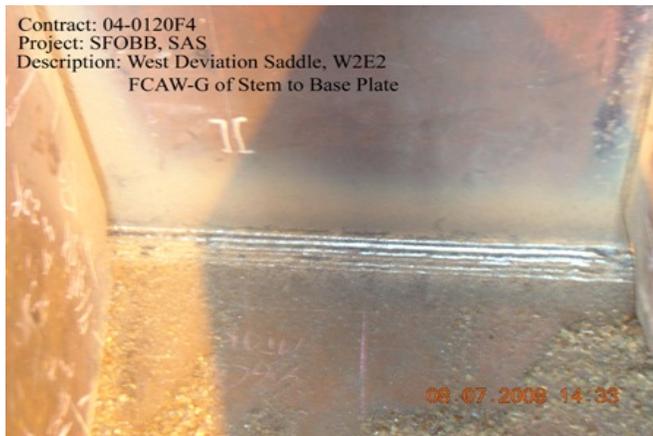
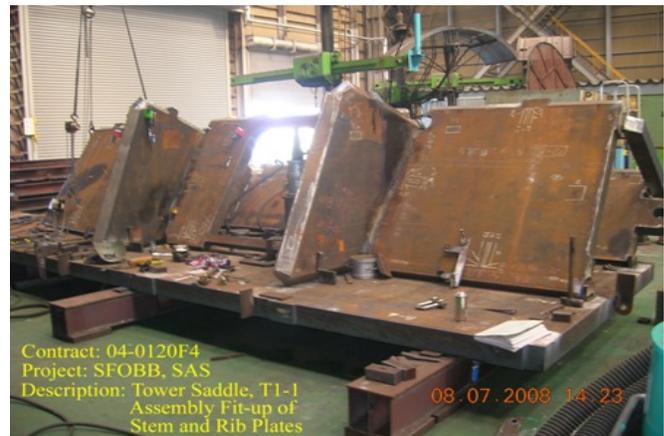
At the start of the shift the QA inspector traveled to the Fabrication Shop # 4 to observe the continued Partial Joint Penetration (PJP) groove welding of the structural steel plate components for the West Deviation Saddle identified as W2E2. The Welding Procedure Specification (WPS) SJ-3011-1 and the Distortion Control Plan, identified as Document SJ-3109 Revision 3 was utilized by the Japan Steel Works, Ltd. (JSW) personnel during the performance of the production welding of the stem plate to base plate connection identified as E2S-2L. The WPS and the Distortion Control Plan were also used as a reference during QC verification of the welding parameters and the monitoring of the weld sequence. The production welding sequence was performed as per Attachment 5, Case 2 Step 1 and Attachment 6, Step 5 of the Distortion Control Plan. The welding was performed in the Flat (1G) position with the work in the horizontal plane and the weld metal deposited from above.

Later in the shift the QA inspector observed the Japan Steel Works, Ltd. personnel performing the assembly fit-up, alignment and tack welding of the stem and rib plates on the Tower Saddle identified as T1-1. The minimum preheat temperatures of 160 degrees Celsius was verified by QC inspector prior to the tack welding which was performed by JSW welding personnel Ohta-Yoshihiro, ID 08-2017 utilizing the Shielded Metal Arc Welding (SMAW) process as per the Welding Procedure Specification (WPS) SJ-3012-2 during the tack welding of the stem plate to rib plate connection identified as 7Y-6V (1-2) and 7Y-8V (1-3). The WPS was also used by the QC inspector as a reference during the QC verification of the welding parameters. The tack welding was performed in the vertical (3G) position utilizing the 4.0 mm electrode.

The digital photographs on Page 3 of this report illustrates the observations of the activities performed on this date.
