DEPARTMENT OF TRANSPORTATION

Quality Assurance and Source Inspection

WELDING INSPECTION REPORT

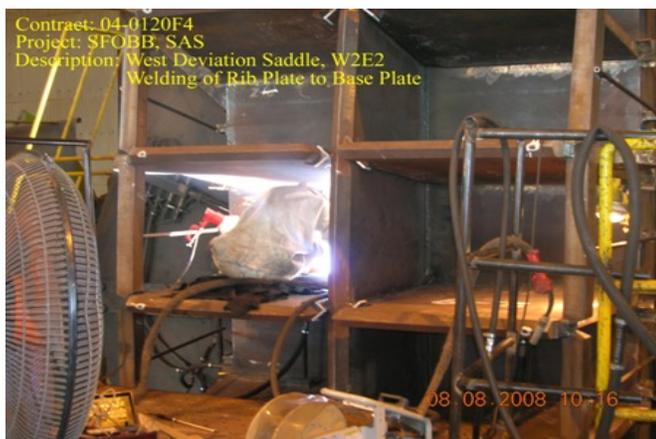
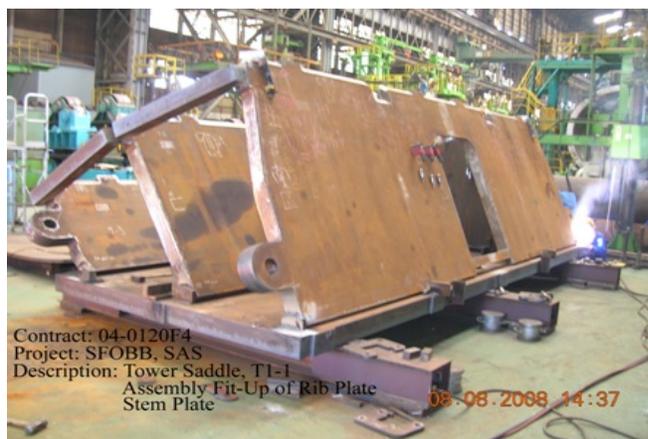
At the start of the shift the QA inspector traveled to the Fabrication Shop # 4 to observe the continued Partial Joint Penetration (PJP) groove welding of the structural steel plate components for the West Deviation Saddle identified as W2E2. The Welding Procedure Specification (WPS) SJ-3011-2 and the Distortion Control Plan, identified as Document SJ-3109 Revision 3 was utilized by the Japan Steel Works, Ltd. (JSW) personnel during the performance of the production welding of the rib plate to base plate connection identified as EY2-9L and EY2-10L.

At approximately 1100 hours the QA inspector observed the Japan Steel Works, Ltd. personnel performing the assembly fit-up, alignment and tack welding of the stem and rib plates on the Tower Saddle identified as T1-1. The minimum preheat temperatures of 160 degrees Celsius was verified by QC inspector prior to the tack welding which was performed by JSW welding personnel Ohta-Yoshihiro, ID 08-2017 utilizing the Shielded Metal Arc Welding (SMAW) process as per the Welding Procedure Specification (WPS) SJ-3012-2 during the tack welding of the stem plate to rib plate connection identified as 7Y-9V (1-2) and 7Y-9V (1-3). The WPS was also used by the QC inspector as a reference during the QC verification of the welding parameters. The tack welding was performed in the vertical (3G) position utilizing the 4.0 mm electrode.

The digital photographs, below illustrates the observations of the activities performed on this date.
