DEPARTMENT OF TRANSPORTATION

Contract #: 04-0120F4Cty: SF/ALA Rte: 80 PM: 13.2/13.9File #: 69.28**WELDING INSPECTION REPORT****Resident Engineer:** Pursell, Gary**Address:** 333 Burma Road**City:** Oakland, CA 94607**Report No:** WIR-003426**Date Inspected:** 28-Jul-2008**Project Name:** SAS Superstructure**OSM Arrival Time:** 2200**Prime Contractor:** American Bridge/Fluor Enterprises, a JV**OSM Departure Time:** 730**Contractor:** Zhenhua Port Machinery Company, Ltd (ZPMC), Changxing Island **Location:** Shanghai, China**CWI Name:** Sun Bo, Xu Le feng**CWI Present:** Yes No**Inspected CWI report:** Yes No N/A**Rod Oven in Use:** Yes No N/A**Electrode to specification:** Yes No N/A**Weld Procedures Followed:** Yes No N/A**Qualified Welders:** Yes No N/A**Verified Joint Fit-up:** Yes No N/A**Approved Drawings:** Yes No N/A**Approved WPS:** Yes No N/A**Delayed / Cancelled:** Yes No N/A**Bridge No:** 34-0006**Component:** OBG, Tower**Summary of Items Observed:**

WELDING INSPECTION REPORT

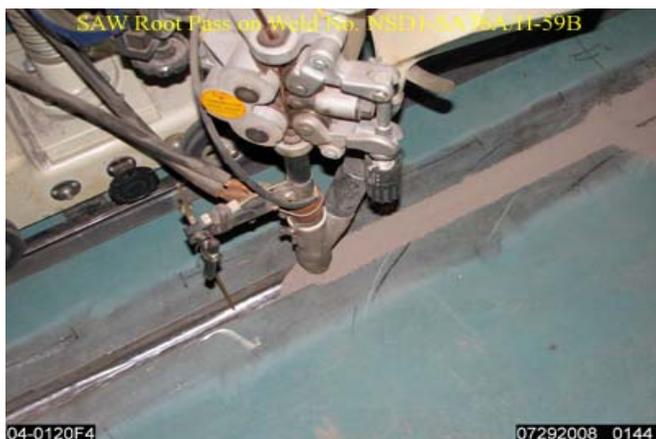
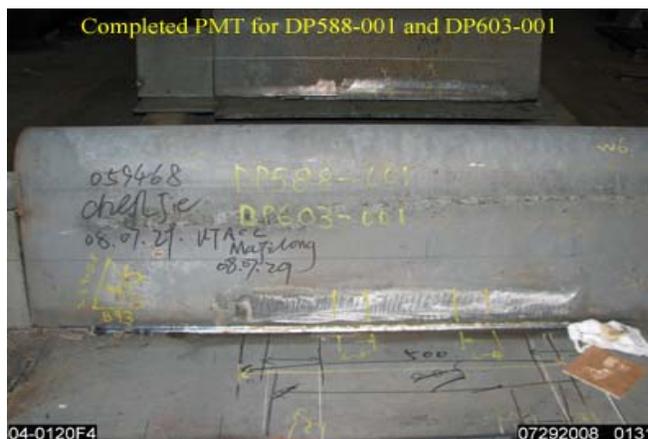
Caltrans Quality Assurance (QA) Inspector, Ken Jobes, was present to monitor activities associated with the Production Monitoring Test (PMT) of Orthotropic Box Girder (OBG) Deck Panel U-rib welds. The PMT representing Deck Panels DP588-001 and DP603-001 was monitored. After MT of the tack welds was accepted by ZPMC Level II MT Technician, Cai Xin Xin, the three ribs (six welds) were simultaneously welded to the

simulated deck plate in the horizontal groove (2G) welding position. The Welding Procedure Specification (WPS) used was WPS-B-T-2342-U1(Urib)-4. It is a combination procedure using gas metal arc welding (GMAW) for the root pass and submerged arc welding (SAW) for the cover or fill pass. The filler metals being used were verified to be as specified on the WPS; 1.4 mm diameter, ER70S-6 (JM-56) for GMAW and 4.8 mm diameter EH14K (H14) for SAW. During the test, the Caltrans QA Inspector recorded the parameters of amperage, voltage, and travel speed on the U-Ribs PMT Inspection Sheet, dated 07-29-08, for both welding processes. The name of the gantry operator and each of the six welding operators' identification numbers were also recorded on the U-Ribs PMT Inspection Sheet. ZPMC Certified Welding Inspector (CWI), Sun Bo (08021741) and ABF QA Inspector Whang Zhen Hua were present during welding.

The final weld was visually examined and accepted by ZPMC CWI, Sun Bo; and ABF QA Inspector Whang Zhen Hua. All welds appeared to meet the specified visual examination acceptance criteria.. After ultrasonic examination (UT) and acceptance by ZPMC Level II UT Technician, Ma Ji Long, the Caltrans QA Inspector designated the locations for the fifteen required macro-etch specimens. All macro-etch specimens were prepared and found acceptable by the ZPMC CWI, and the ABF QA Inspector. The macro-etch specimens were then examined by the Caltrans QA Inspector and the depth of penetration on each measured and the results recorded on Caltrans Project 04-0120F4 SAS OBG Fabrication Macro Etch Log.
