Contract #: 04-0120F4Cty: SF/ALA Rte: 80 PM: 13.2/13.9File #: 69.28**WELDING INSPECTION REPORT****Resident Engineer:** Pursell, Gary**Address:** 333 Burma Road**City:** Oakland, CA 94607**Report No:** WIR-003460**Date Inspected:** 14-Jul-2008**Project Name:** SAS Superstructure**OSM Arrival Time:****Prime Contractor:** American Bridge/Fluor Enterprises, a JV**OSM Departure Time:****Contractor:** Zhenhua Port Machinery Company, Ltd (ZPMC), Changxing Island **Location:** Shanghai, China**CWI Name:** Wu Shi Feng**CWI Present:** Yes No**Inspected CWI report:** Yes No N/A**Rod Oven in Use:** Yes No N/A**Electrode to specification:** Yes No N/A**Weld Procedures Followed:** Yes No N/A**Qualified Welders:** Yes No N/A**Verified Joint Fit-up:** Yes No N/A**Approved Drawings:** Yes No N/A**Approved WPS:** Yes No N/A**Delayed / Cancelled:** Yes No N/A**Bridge No:** 34-0006**Component:** OBG rib to side plate welds**Summary of Items Observed:**

Sub-Assembly Shop - Bay 4

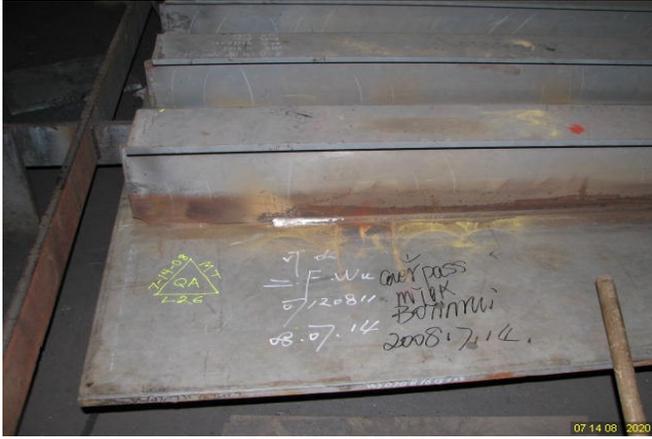
Caltrans Quality Assurance Inspector George Goulet (QA Inspector) performed final MT on SP174-001- welds 007 through 018. No apparent indications were observed. QA Inspector notated QA Inspector's MT acceptance on the side plate. See photo below showing notations by ZPMC and QA Inspector.
