Contract #: 04-0120F4Cty: SF/ALA Rte: 80 PM: 13.2/13.9File #: 13.28**WELDING INSPECTION REPORT****Resident Engineer:** Pursell, Gary**Address:** 333 Burma Road**City:** Oakland, CA 94607**Report No:** WIR-003461**Date Inspected:** 12-Aug-2008**Project Name:** SAS Superstructure**OSM Arrival Time:** 700**Prime Contractor:** American Bridge/Fluor Enterprises, a JV**OSM Departure Time:** 1530**Contractor:** Oregon Iron Works Clackamas, Or.**Location:** Clackamas, Oregon**CWI Name:** Scott Reed**CWI Present:** Yes No**Inspected CWI report:** Yes No N/A**Rod Oven in Use:** Yes No N/A**Electrode to specification:** Yes No N/A**Weld Procedures Followed:** Yes No N/A**Qualified Welders:** Yes No N/A**Verified Joint Fit-up:** Yes No N/A**Approved Drawings:** Yes No N/A**Approved WPS:** Yes No N/A**Delayed / Cancelled:** Yes No N/A**Bridge No:** 34-0006**Component:** Hinge K components**Summary of Items Observed:**

# WELDING INSPECTION REPORT

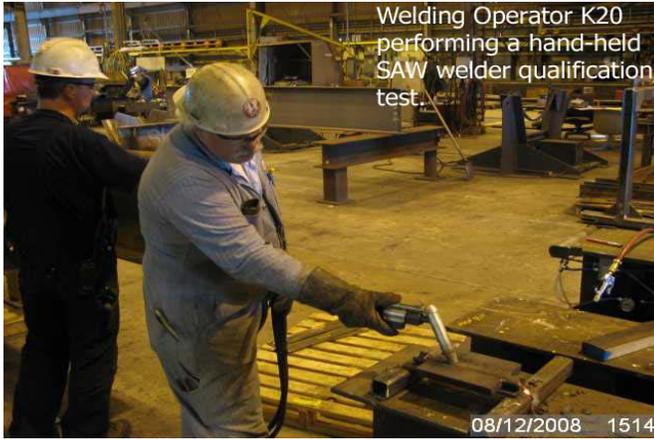
The QA Inspector randomly observed that third party Quality Control (QC) Inspector Mr. Scott Reed was monitoring a hand held submerged arc welding (SAW) welder qualification test being performed by OIW Welding Operator Mr. Randy Kleeman, welder identification (WID) K20. Please see photo below for additional information. During one of the weld passes the QA Inspector observed that Mr. Kleeman performed a travel speed of approximately 215 millimeters per minute. The QA Inspector asked Mr. Reed what the minimum travel speed allowed by the welding procedure specification (WPS). The QA Inspector observed that the WPS referred to a table for the travel speed limitations and the table was not attached to the WPS. The QA Inspector inquired as to how a welder qualification test could be performed if the travel speed information is not available. Mr. Reed informed the QA Inspector that he would contact OIW Welding Engineer Mr. Greg Roberts and obtain the travel speed information to determine if the above mentioned travel speed is within the limitations of the WPS. Mr. Reed also informed the QA Inspector that if the travel speed observed during the test did not conform to the limitations of the WPS he would fail the test.
