DEPARTMENT OF TRANSPORTATION

Contract #: 04-0120F4Cty: SF/ALA Rte: 80 PM: 13.2/13.9File #: 69.28**WELDING INSPECTION REPORT****Resident Engineer:** Pursell, Gary**Address:** 333 Burma Road**City:** Oakland, CA 94607**Report No:** WIR-003585**Date Inspected:** 20-Aug-2008**Project Name:** SAS Superstructure**OSM Arrival Time:** 1400**Prime Contractor:** American Bridge/Fluor Enterprises, a JV**OSM Departure Time:** 2300**Contractor:** Zhenhua Port Machinery Company, Ltd (ZPMC), Changxing Island **Location:** Shanghai, China**CWI Name:** Zhao Chen Sun**CWI Present:** Yes No**Inspected CWI report:** Yes No N/A**Rod Oven in Use:** Yes No N/A**Electrode to specification:** Yes No N/A**Weld Procedures Followed:** Yes No N/A**Qualified Welders:** Yes No N/A**Verified Joint Fit-up:** Yes No N/A**Approved Drawings:** Yes No N/A**Approved WPS:** Yes No N/A**Delayed / Cancelled:** Yes No N/A**Bridge No:** 34-0006**Component:** OBG and Tower**Summary of Items Observed:**

Caltrans Quality Assurance (QA) Inspector, Larry Viars was present to observe fabrication and perform Magnetic Particle Testing (MT) of Orthotropic Box Girder (OBG) and Tower components, for the San Francisco Oakland Bay Sel

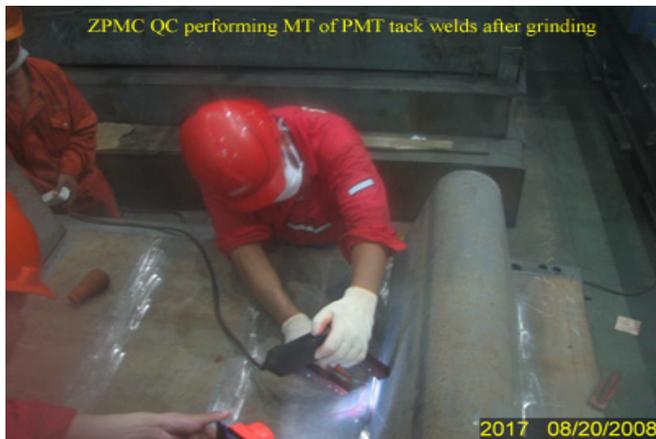
This QA Inspector observed ZPMC personnel performing various activities in relation to OBG deck panel Production Monitoring Test and production fabrication. Activities included ZPMC performing MT the PMT tack welds after grinding, grinding U-rib Complete Joint Penetration (CJP) Splice welds and tack welding of U-ribs to deck plate. Please see the attached Photo below of ZPMC QC performing MT on PMT tack welds. Testing and

fabrication activities appeared to in general conformance with contract documents.
