Contract #: 04-0120F4Cty: SF/ALA Rte: 80 PM: 13.2/13.9File #: 13.28**WELDING INSPECTION REPORT****Resident Engineer:** Pursell, Gary**Address:** 333 Burma Road**City:** Oakland, CA 94607**Report No:** WIR-003753**Date Inspected:** 04-Sep-2008**Project Name:** SAS Superstructure**OSM Arrival Time:** 700**Prime Contractor:** American Bridge/Fluor Enterprises, a JV**OSM Departure Time:** 1530**Contractor:** Oregon Iron Works Clackamas, Or.**Location:** Clackamas, Oregon**CWI Name:** Scott Reed**CWI Present:** Yes No**Inspected CWI report:** Yes No N/A**Rod Oven in Use:** Yes No N/A**Electrode to specification:** Yes No N/A**Weld Procedures Followed:** Yes No N/A**Qualified Welders:** Yes No N/A**Verified Joint Fit-up:** Yes No N/A**Approved Drawings:** Yes No N/A**Approved WPS:** Yes No N/A**Delayed / Cancelled:** Yes No N/A**Bridge No:** 34-0006**Component:** Hinge K Components**Summary of Items Observed:**

On this date, Caltrans Quality Assurance (QA) Inspector Mr. Danny C. White (B89) was present at Oregon Iron Works (OIW) for the purpose of monitoring fabrication and welding operations of the Hinge K Pipe Beam at the OIW fabrication and welding shop in Clackamas, Oregon.

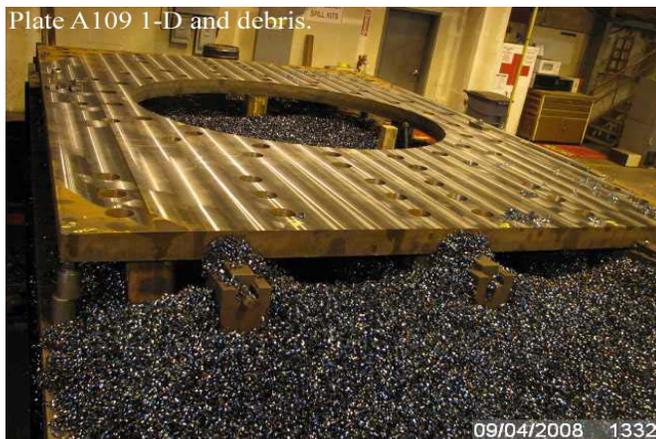
The QA Inspector performed random observations in the fabrication shop in bay #1 and observed Mr. Scott Jones was performing machining operations on the base-plate component marked as A109-1D for this job. The QA Inspector did observe that an unusual amount of machine debris was removed from the above mentioned item. Mr. Jones informed the QA Inspector that the plate is within the tolerance allowed by the drawing. See photo on the left below for additional information.

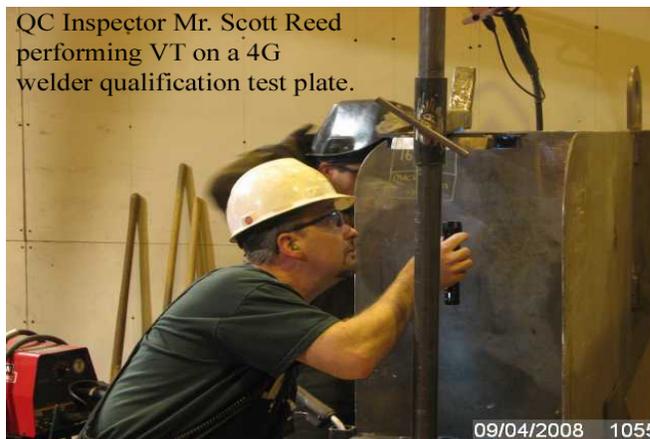
Also in bay #1 the QA Inspector randomly observed third party Quality Control (QC) Inspector Mr. Scott Reed monitored welder qualification tests performed by OIW welding operators. The QA Inspector observed that several welder qualification tests were performed this day. The QA Inspector did observe Mr. Reed as he performed interpass visual inspection (see photo on the right below for additional information) as well as monitoring welding parameters during the above mentioned tests.
